ACTION HISTORY OF RTI REQUEST No.WLIOI/R/E/21/00071

Deepor Beel Railway Track Mitigation Plan

TR No. 2021/12

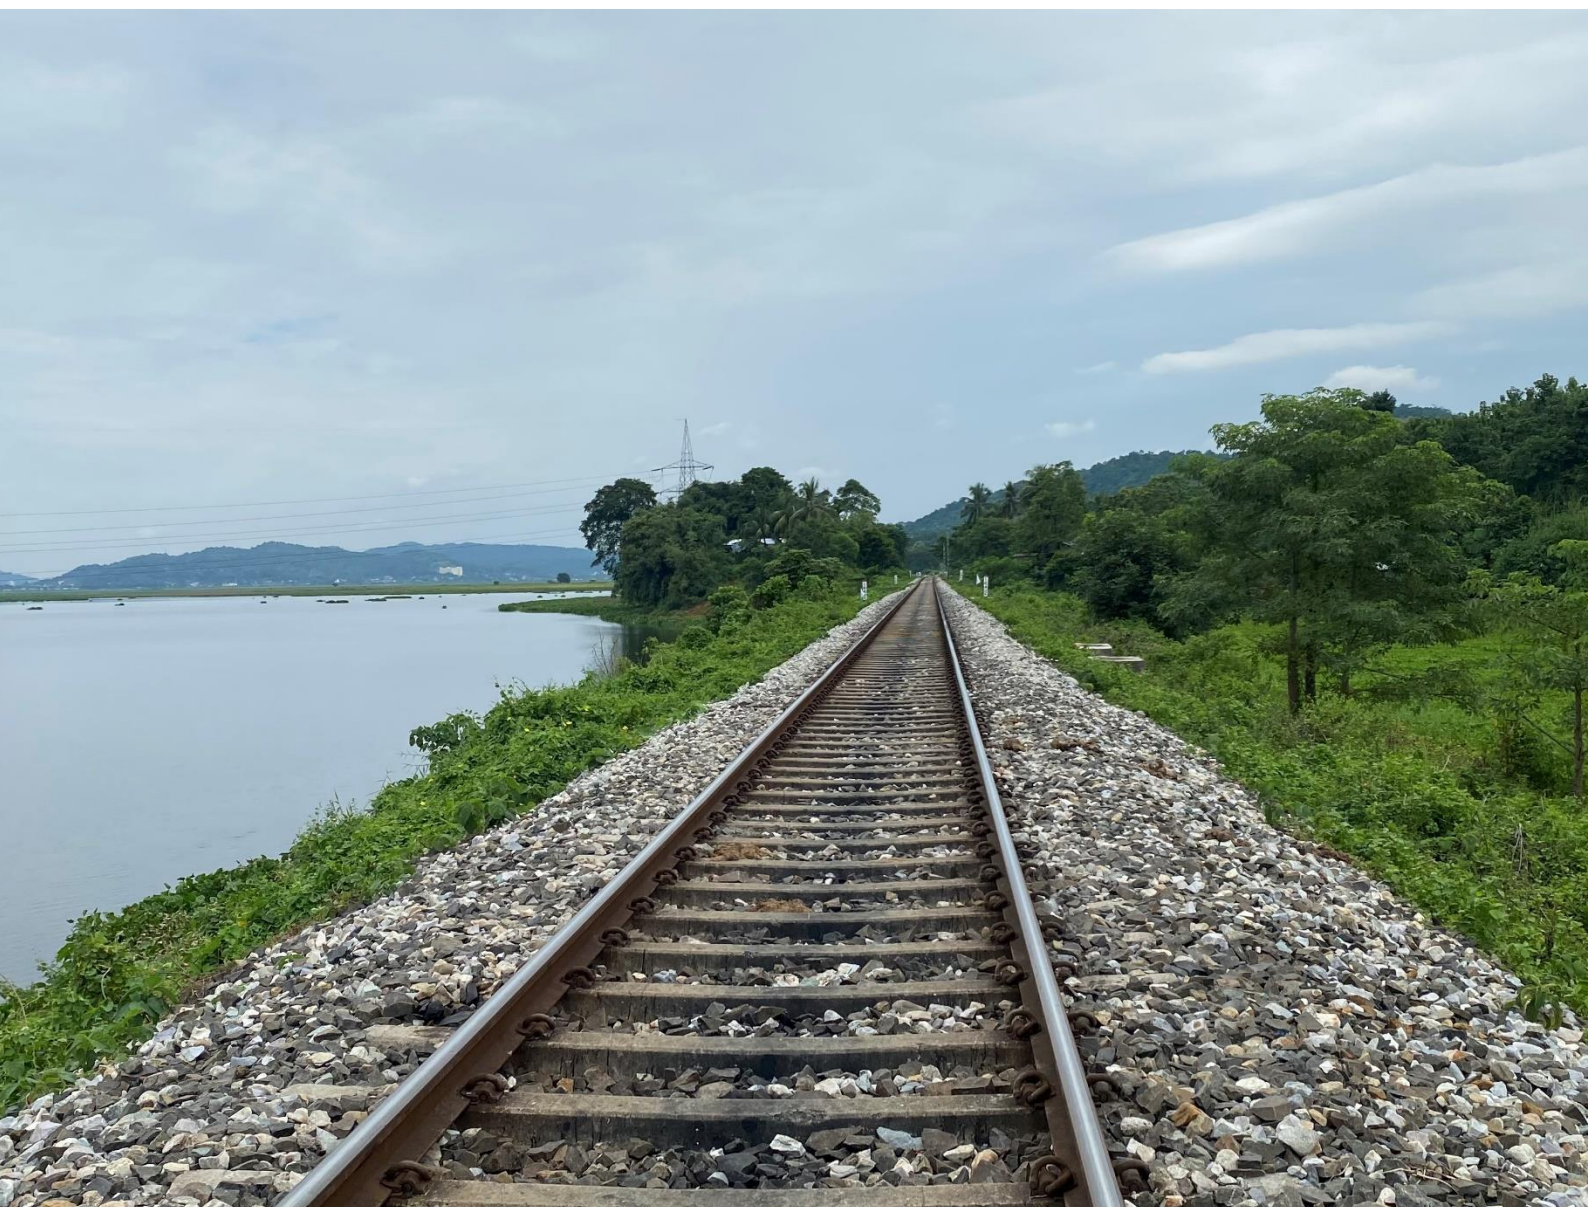
Figure 1. Railway track, elephant corridors and mitigation measures proposed by NFR for doubling of railway track between Azara – Kamakhya (Chainage 163/000 – 168/900) passing through the southern boundary of Deepor Beel, Guwahati, Assam.

A total of four mitigation measures have been proposed by NFR, the details of which are given below (Table 1 and Figure 1). The height of all structures is ≥ 7 m.

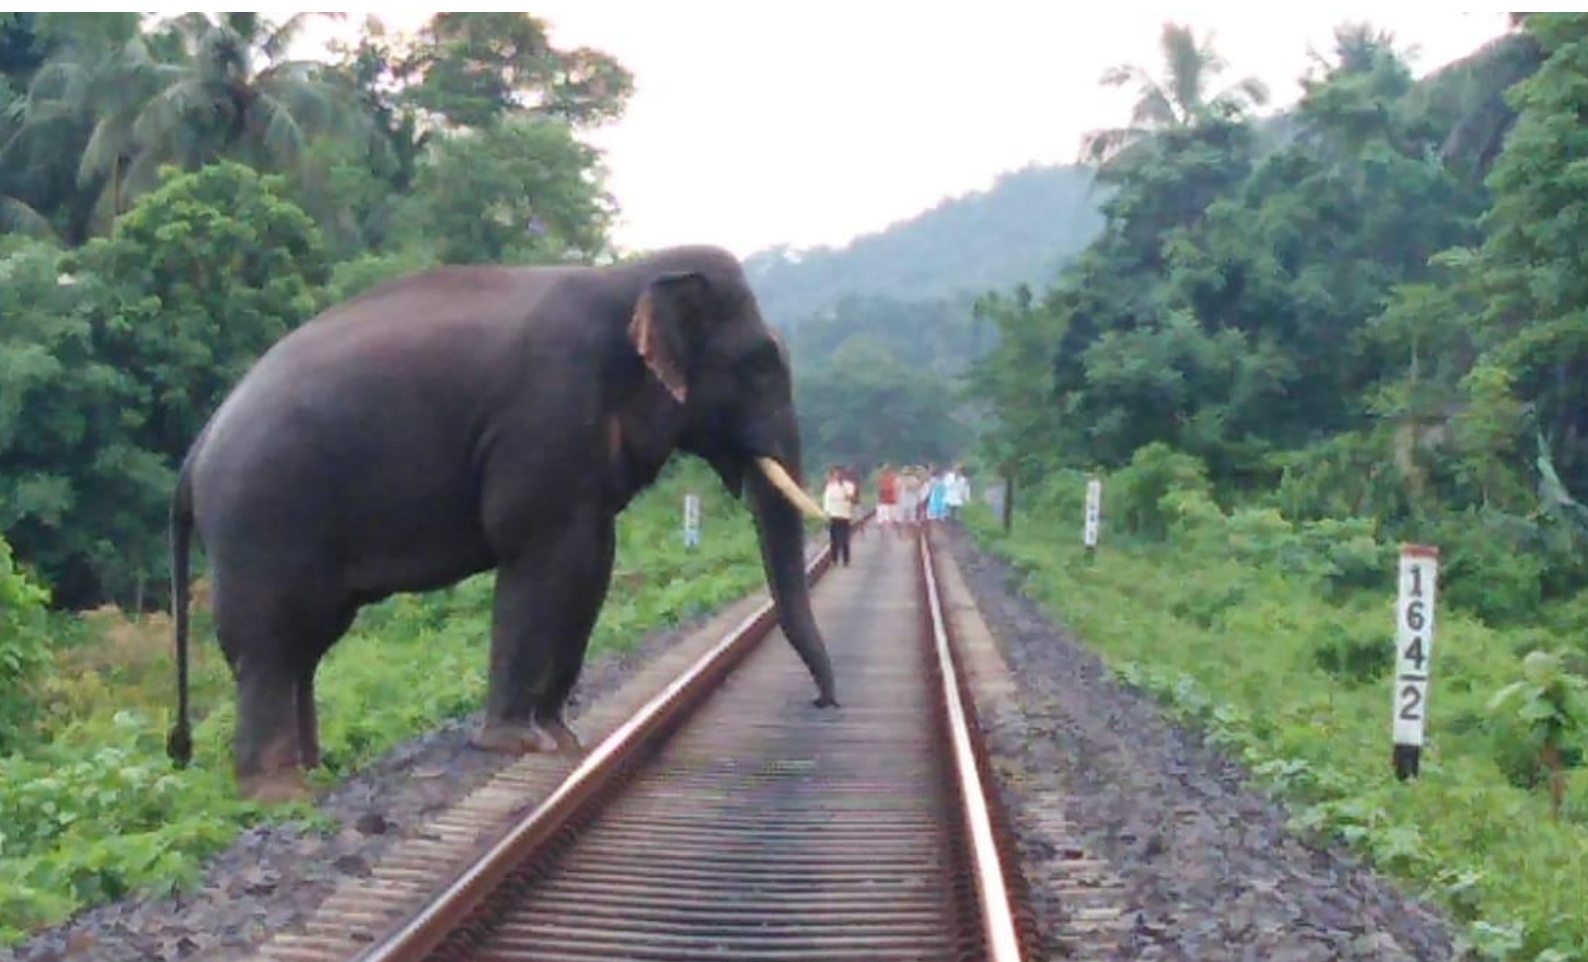
Figure 2. Railway track, elephant corridors and mitigation measures proposed by NFR and recommended by WII for doubling of railway track between chainage 164/000 – 164/200 of the Azara – Kamakhya railway line passing through the southern boundary of Deepor Beel, Guwahati, Assam.

One mitigation structure (RCC box) measuring 200 m wide and 7 m high has been proposed on the first corridor (Chainage 164/000 – 164/150). Additionally, an underpass measuring 150 m wide and 7 m high on the road parallel to the railway track is recommended. It is also recommended to install guide walls to direct animal movement first towards the road underpass and then towards the railway track underpass. ***It is recommended to construct the underpasses as RCC structures with a span of 12 m and pillar-type divisions.*** The details of the proposed and recommended mitigation measures are provided in Table 2 and Figure 2.

S. No.	Mitigation Measure	Chainage/GPS location	Dimensions (m) Width x height
1.	Underpass on railway track	164/000 – 164/200	200 x 7
2.	Underpass on road	Start: 26° 6'19.29"N 91°37'43.23"E End: 26° 6'17.33"N 91°37'39.70"E	150 x 7
3.	Guide walls	.kml provided (I.GW1 & I.GW2)	570 (west side) 220 (east side)

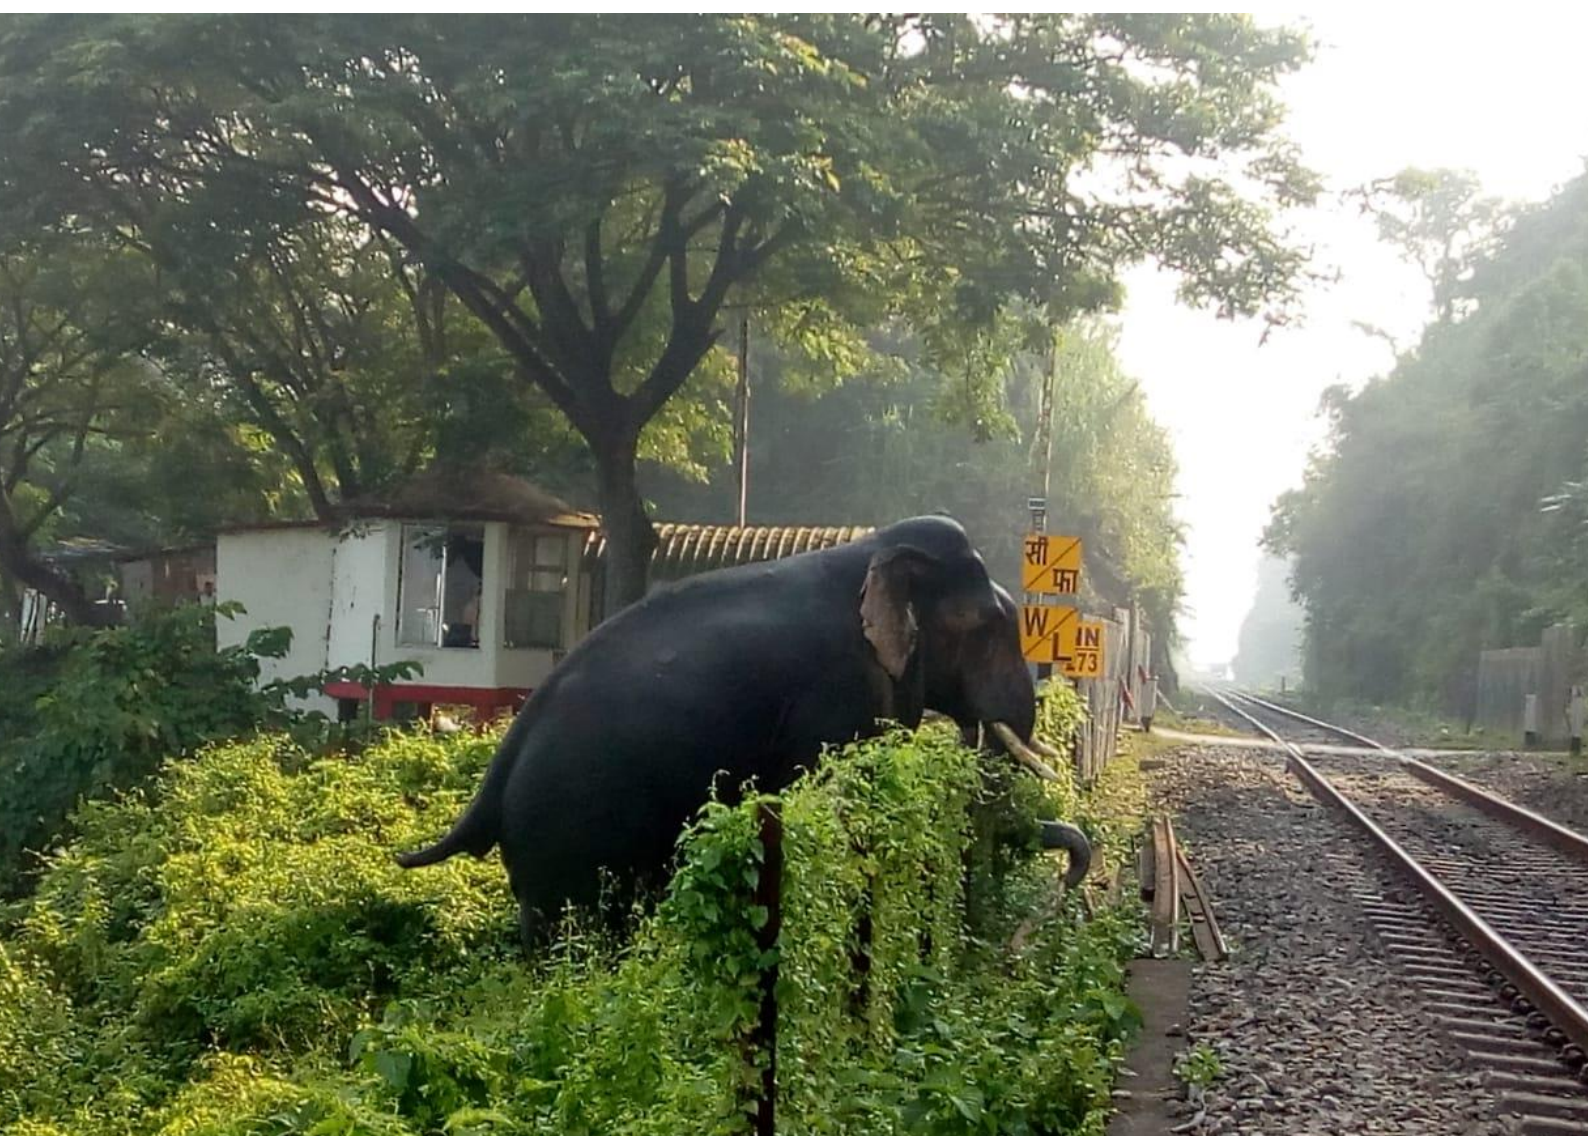
Figure 3. Railway track, elephant corridors and mitigation measures proposed by NFR and recommended by WII for doubling of railway track between chainage 164/500 – 164/600 of the Azara – Kamakhya railway line passing through the southern boundary of Deepor Beel, Guwahati, Assam.

One mitigation structure (RCC box) measuring 100 m wide and 7 m high has been proposed on the second corridor (Chainage 164/400 – 164/600). Additionally, an underpass measuring 100 m wide and 7 m high on the road parallel to the railway track is recommended. It is also recommended to install guide walls to direct animal movement first towards the road underpass and then towards the railway track underpass. ***It is recommended to construct the underpasses as RCC structures with a span of 12 m and pillar-type divisions.*** The details of the proposed and recommended mitigation measures are provided in Table 3 and Figure 3.

S. No.	Mitigation Measure	Chainage/GPS location	Dimensions (m) Width x height
1.	Underpass on railway track	164/500 – 164/600	100 x 7
2.	Underpass on road	Start: 26° 6'25.71"N 91°37'58.73"E End: 26° 6'26.24"N 91°37'55.24"E	100 x 7
3.	Guide walls	.kml provided (II.GW1 & II.GW2)	246 (west side) 146 (east side)

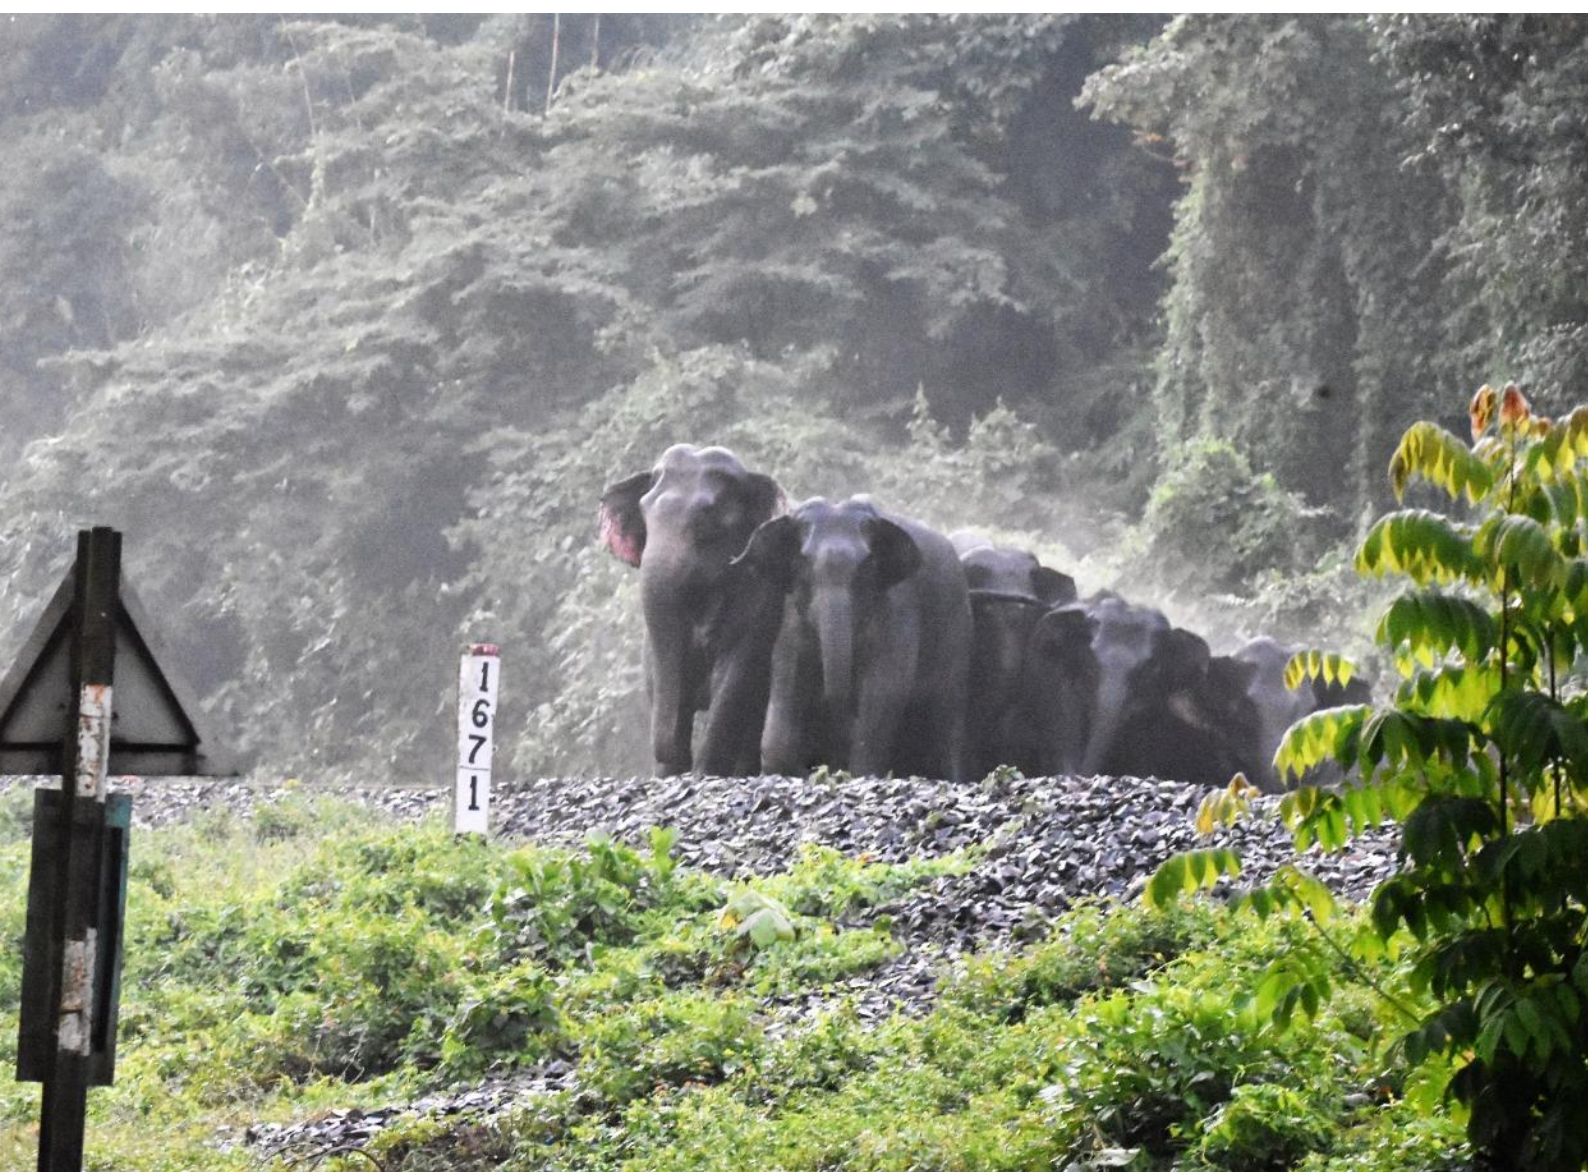
Figure 4. Railway track, elephant corridors and mitigation measures proposed by NFR and recommended by WII for doubling of railway track between chainage 165/200 – 165/300 of the Azara – Kamakhya railway line passing through the southern boundary of Deepor Beel, Guwahati, Assam.

One mitigation structure (RCC box) measuring 100 m wide and 7 m high has been proposed on the third corridor (Chainage 165/100 – 165/300). Additionally, an underpass measuring 100 m wide and 7 m high on the road parallel to the railway track is recommended. It is also recommended to install guide walls to direct animal movement first towards the road underpass and then towards the railway track underpass. ***It is recommended to construct the underpasses as RCC structures with a span of 12 m and pillar-type divisions.*** The details of the proposed and recommended mitigation measures is provided in Table 4 and Figure 4.

S. No.	Mitigation measure	Chainage/GPS location	Dimensions (m) Width x height
1.	Underpass on railway track	165/200 – 165/300	100 x 7
2.	Underpass on road	Start: 26° 6'30.08"N 91°38'26.67"E End: 26° 6'29.05"N 91°38'23.64"E	100 x 7
3.	Guide walls	.kml provided (III.GW1 & III.GW2)	537 (west side) 370 (east side)

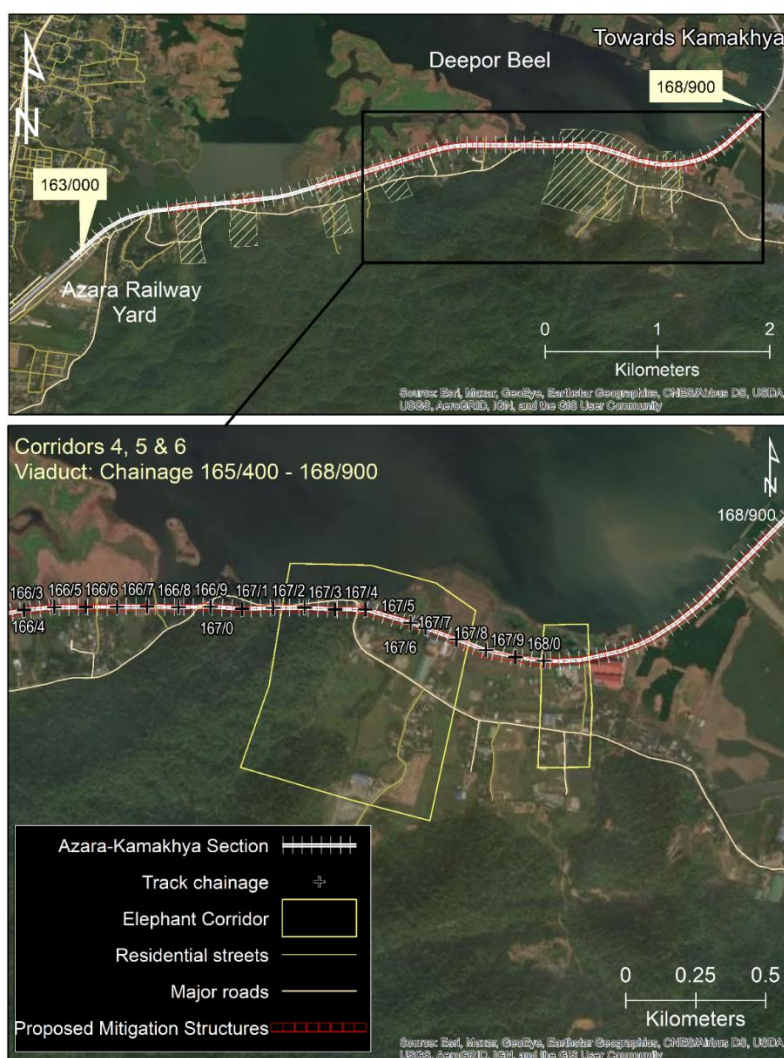
Figure 5. Railway track, elephant corridors and mitigation measures proposed by NFR and recommended by WII for doubling of railway track between chainage 165/400 – 168/900 of the Azara – Kamakhya railway line passing through the southern boundary of Deepor Beel, Guwahati, Assam.

One mitigation structure (viaduct) measuring 3500 m wide and 7 m high (Figure 5) has been proposed on this section. The viaduct covers three designated elephant corridors (Chainage 165/600 – 165/800, 167/100 – 167/700 and 168/000 – 168/150). The details of the proposed and recommended mitigation measures are provided in Table 5 and Figure 5.

S. No.	Mitigation measure	Chainage/GPS location	Dimensions (m) <i>Width x height</i>
1.	Viaduct on railway track	165/400 – 168/900	3500 x 7

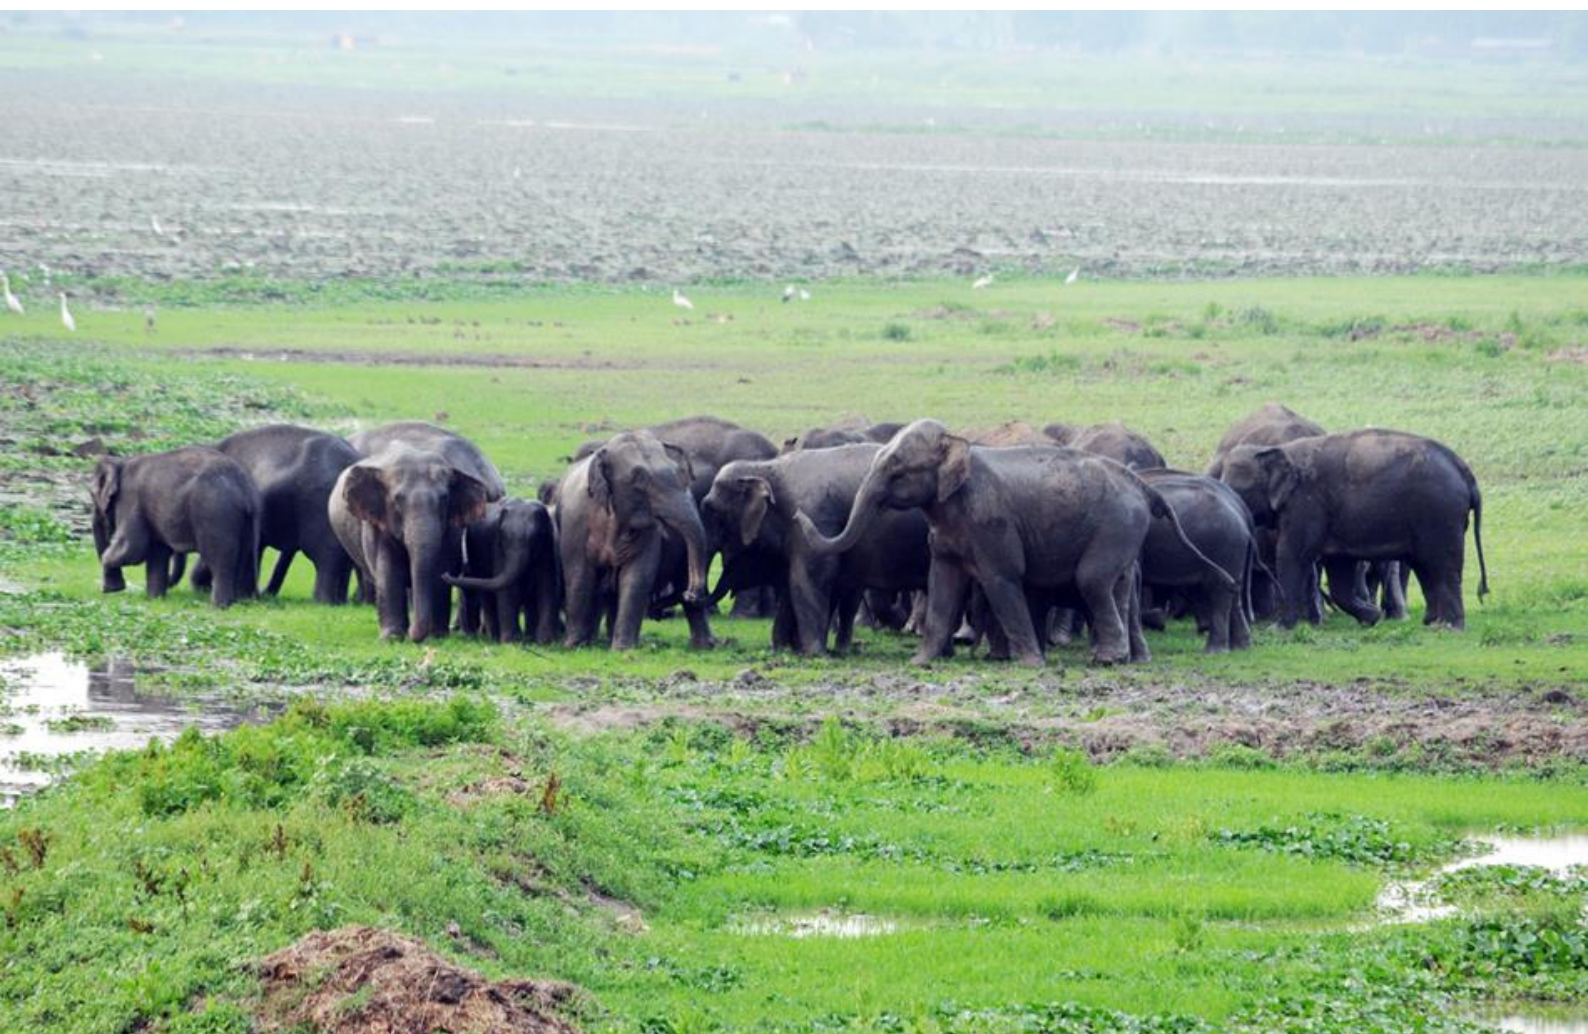
Figure 6. Additional mitigation measures recommended in the first segment (chainage 165/950 – 166/050) of the 3500 m ling viaduct on the Azara – Kamakhya railway line passing through the southern boundary of Deepor Beel, Guwahati, Assam.

An underpass measuring 100 m wide and 7 m high on the road parallel to the railway track is recommended. It is also recommended to install guide walls to direct animal movement first towards the road underpass and then towards the viaduct on the railway track. The details of the proposed and recommended mitigation measures is provided in Table 6 and Figure 6.

S. No.	Mitigation measure	GPS location	Dimensions (m) Width x height
1.	Underpass on road	Start: 26° 6'36.21"N 91°38'50.49"E End: 26° 6'36.38"N 91°38'46.70"E	100 x 7
2.	Guide walls	.kml provided (IV.GW1 & IV.GW2)	270 (west side) 336 (east side)

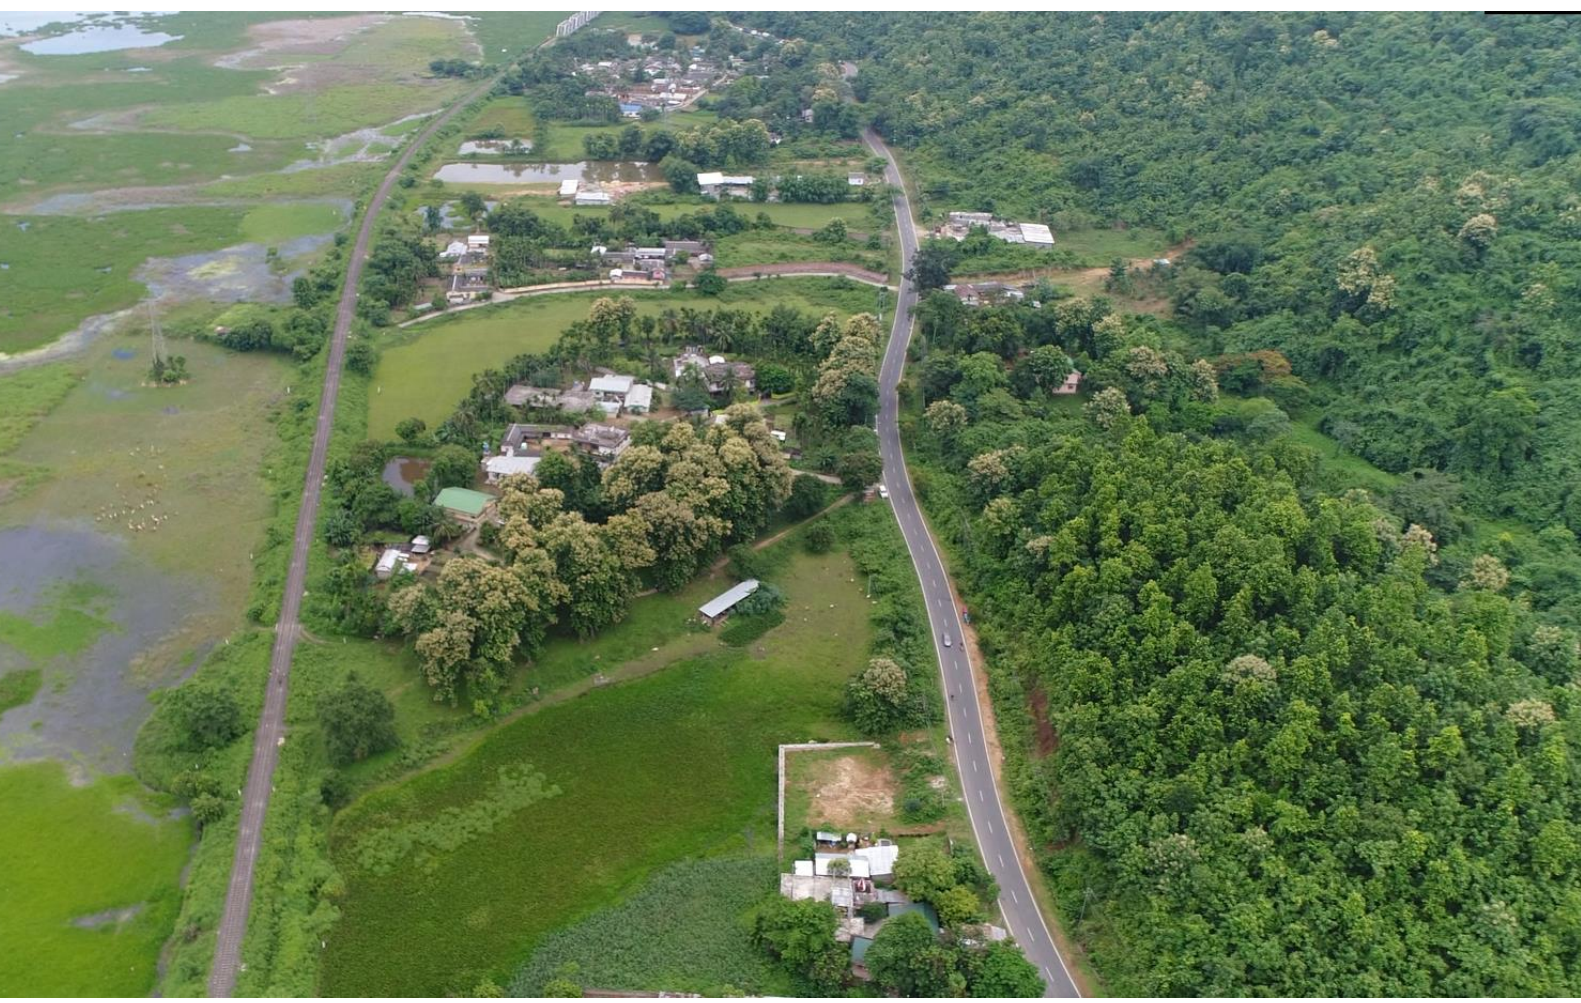
Figure 7. Additional mitigation measures recommended in the second segment (chainage 166/850 – 167/380) of the 3500 m ling viaduct on the Azara – Kamakhya railway line passing through the southern boundary of Deepor Beel, Guwahati, Assam.

It is recommended to elevate the road section between the two level crossings (chainages 166/850 and 167/380) presently crossing over to the north of the railway track (Figure 7). The road must be elevated and brought to the south of the present alignment. The length of the road between the two level crossings is 520 m. The height of the road underpass should be the same as that of the viaduct for the entire stretch (7 m). The details of the proposed and recommended mitigation measures is provided in Table 7 and Figure 7.

S. No.	Mitigation measure	Chainage/GPS location	Dimensions (m) <i>Width x height</i>
1.	Underpass on road	166/850 – 167/380 Start: 26° 6'45.16"N 91°39'16.56"E End: 26° 6'44.74"N 91°39'35.09"E	520 x 7

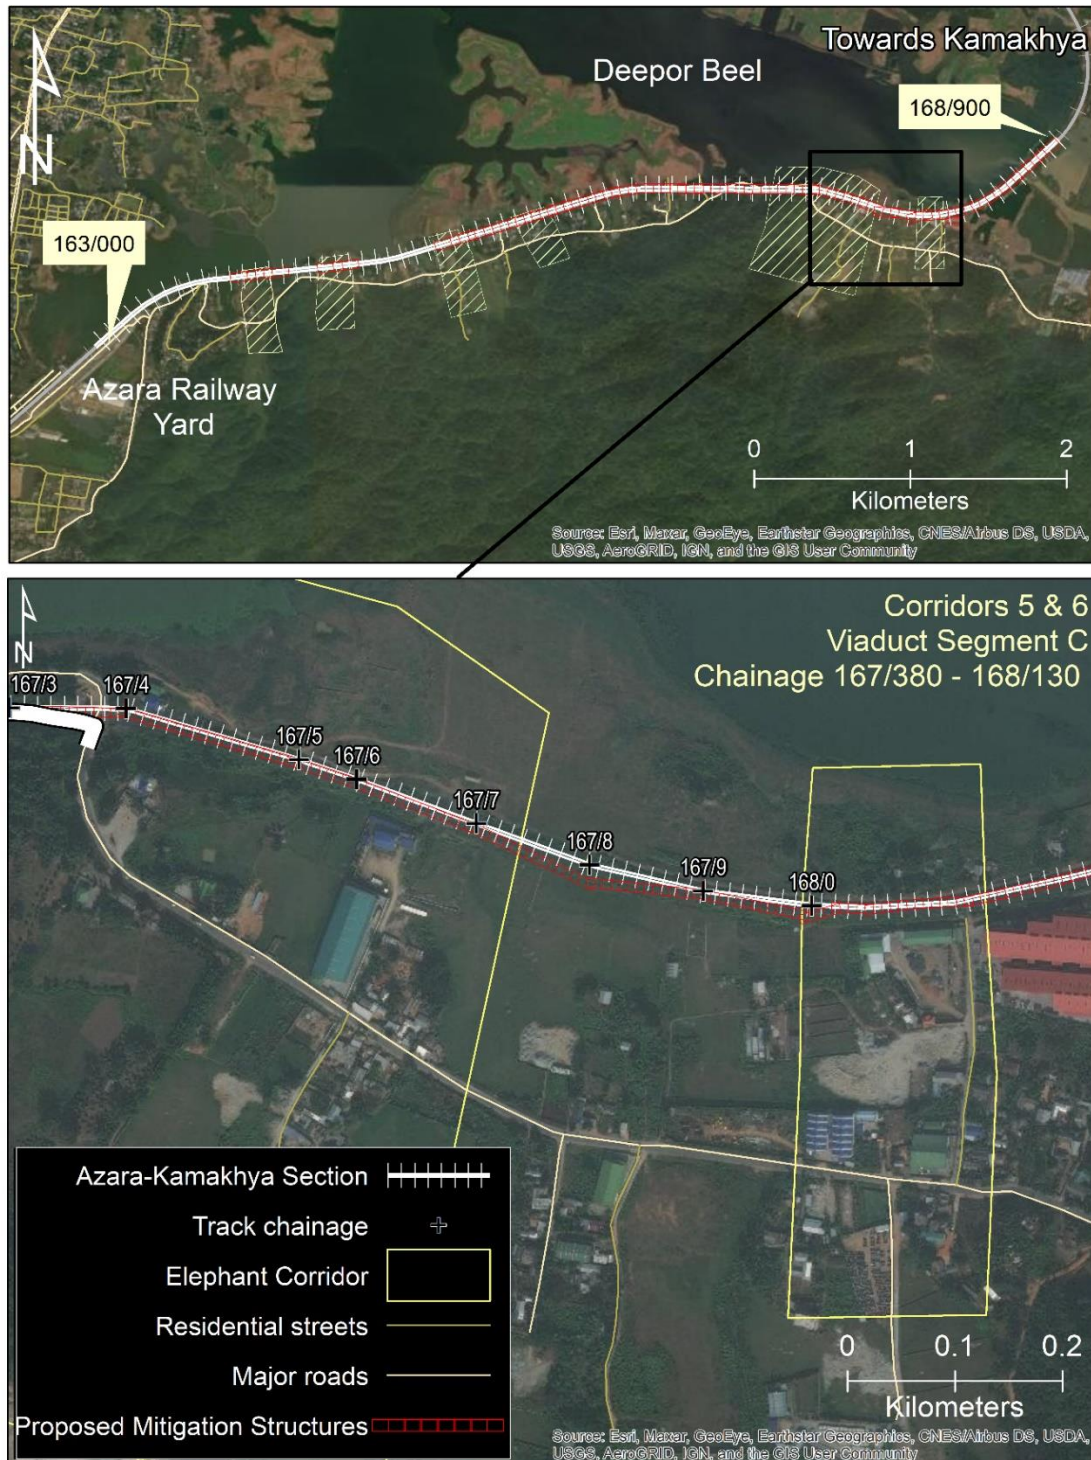
Figure 8. Additional mitigation measures recommended in the third segment (chainage 167/380 – 168/130) of the 3500 m ling viaduct on the Azara – Kamakhya railway line passing through the southern boundary of Deepor Beel, Guwahati, Assam.

An attempt to remove all encroachments falling in the area should be made (Figure 8). This stretch has two critical elephant corridors and if the encroachments are not removed, all mitigation measures would be futile.

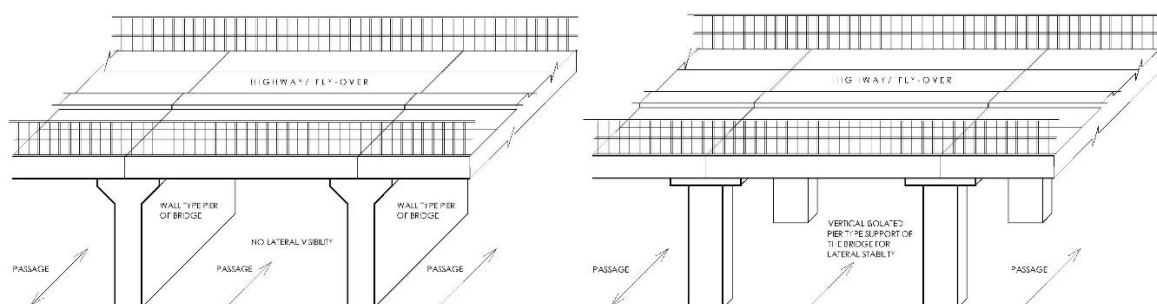
Figure 9 (a) Wall-type division of bridge and (b) pillar-type division

- i. Guide walls are recommended to direct animal movement towards the underpasses.
- ii. The width of individual spans on all crossing structures (road and railway) should be 12 m wide (instead of 5 m wide RCC box).
- iii. The divisions of the crossing structures measuring 100 – 200 m should be of pillar type (instead of wall-type, Figure 9 a and b) with 1.5 m diameter.

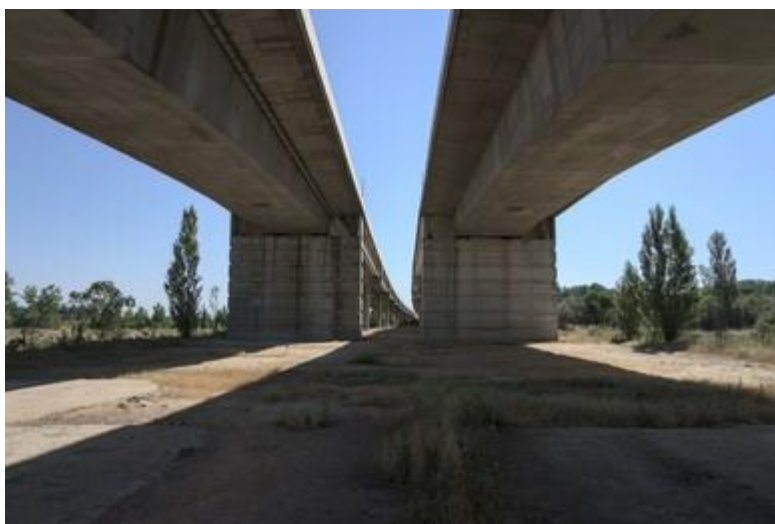
Figure 10. Gap between two parallel bridges (Image: internet)

- iv. Attempts should be made to remove encroachments on forest land between Rani Reserve Forest and Deepor Beel for maintaining elephant movement in the area.
- v. The existing railway bed should be removed, and the height of the track should be taken from the ground level (not from the existing trackbed level).
- vi. The spacing between two railway tracks should be as open and wide as possible. The gap between tracks on crossing structure sections should be of open type (Figure 10).

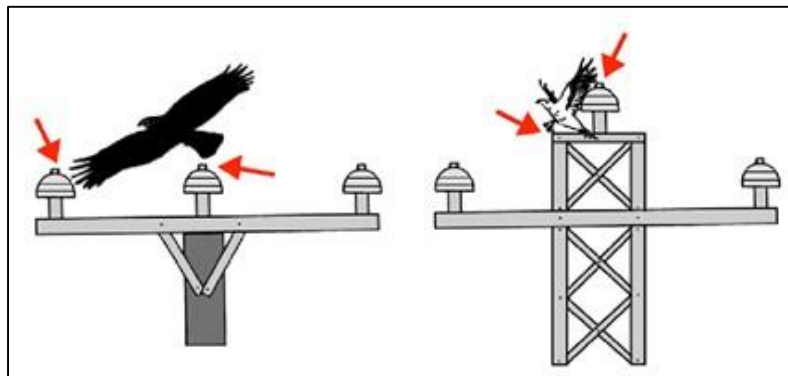
Structural design of the power poles in distribution lines such as separation distances between conducting surfaces as show in the image dictates electrocution risks to birds. (Source: Tinto et al. 2005)

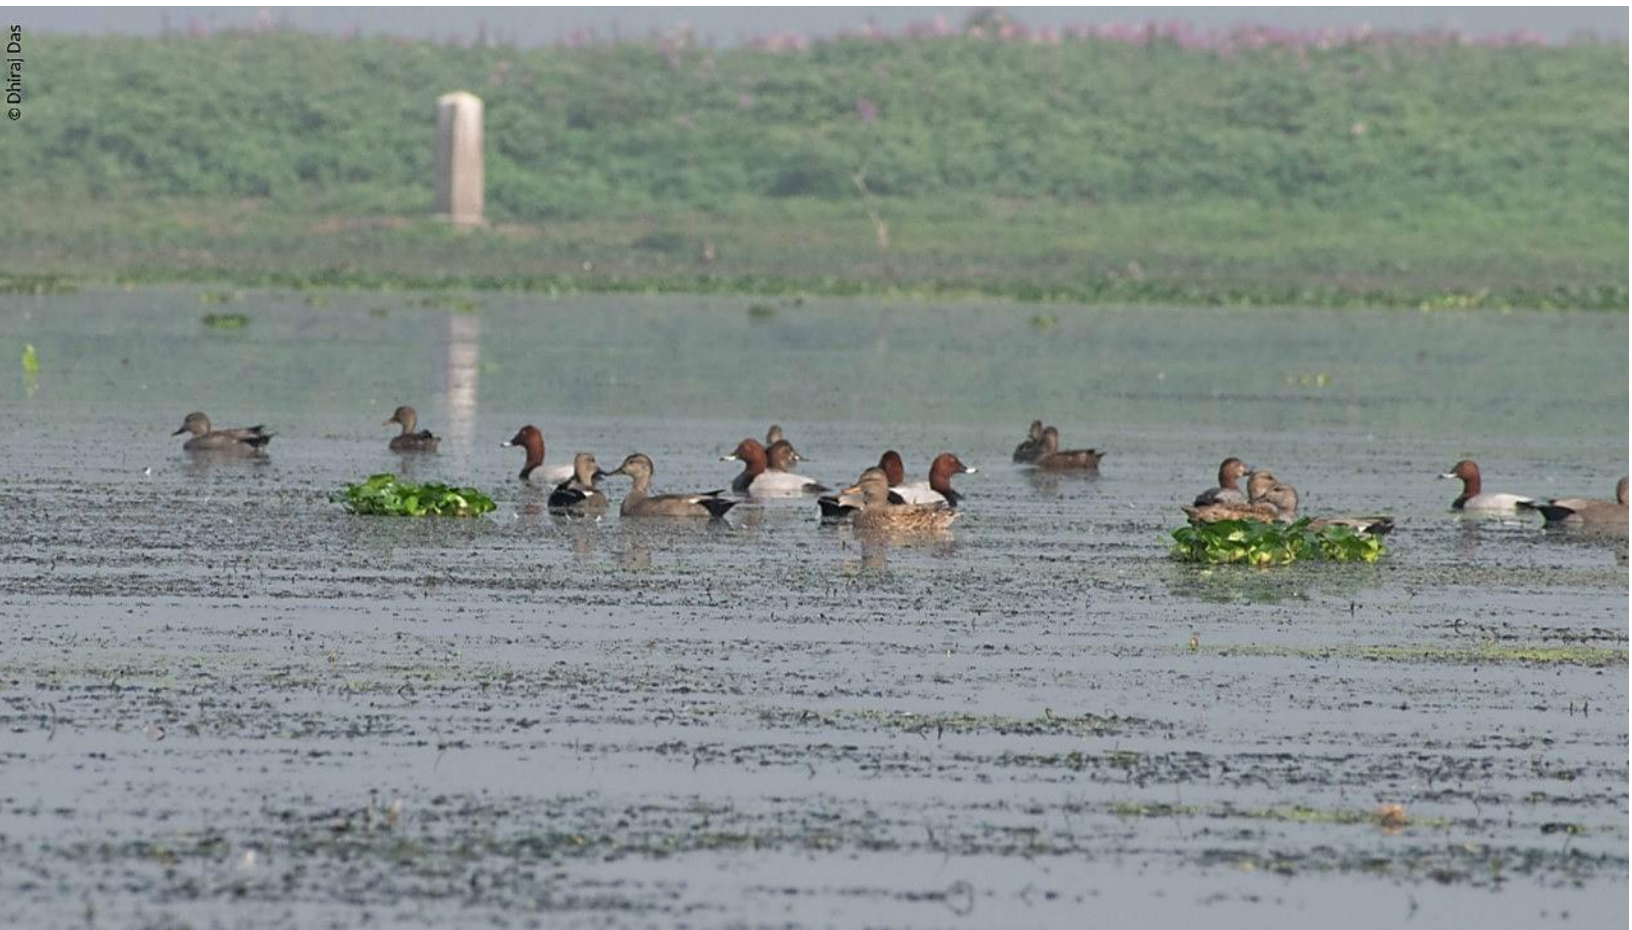
Figure 2. Map of the Deepor Beel wetland showing the 20 grids that were sampled from the survey trails (yellow tracks) to document and map select waterbirds and wetland associated species.

In order to document the spatial distribution of bird species associated with the Beel, a grid-based systematic sampling approach was adopted. For this, the wetland was divided into 20 grids (1 x 1 km) and within each a sampling trail approximately 500 m in length was identified and surveyed by foot (Figure 2). Additionally, few grids being primarily open water expanse were surveyed from a non-motorized boat. The grids were surveyed once every fortnight and in all nine visits were made in each grid between January to first week of May. This period coincided with the wintering and return migration of a number of waterbirds and few water associate species. The grid survey was conducted in the morning between 08:00 to 10:00 am and during the survey information on the bird species along with their abundance were recorded. From the survey data heatmaps of species richness, overall average abundance, and an average Simpson's Evenness Index for each grid was generated to depict areas of high importance for birds within the Beel. The heatmaps were generated in QGIS (Version 3.4.9-Madeira) and were then overlaid with the power lines mapped in the area to assess the collision and electrocution risks posed to birds.

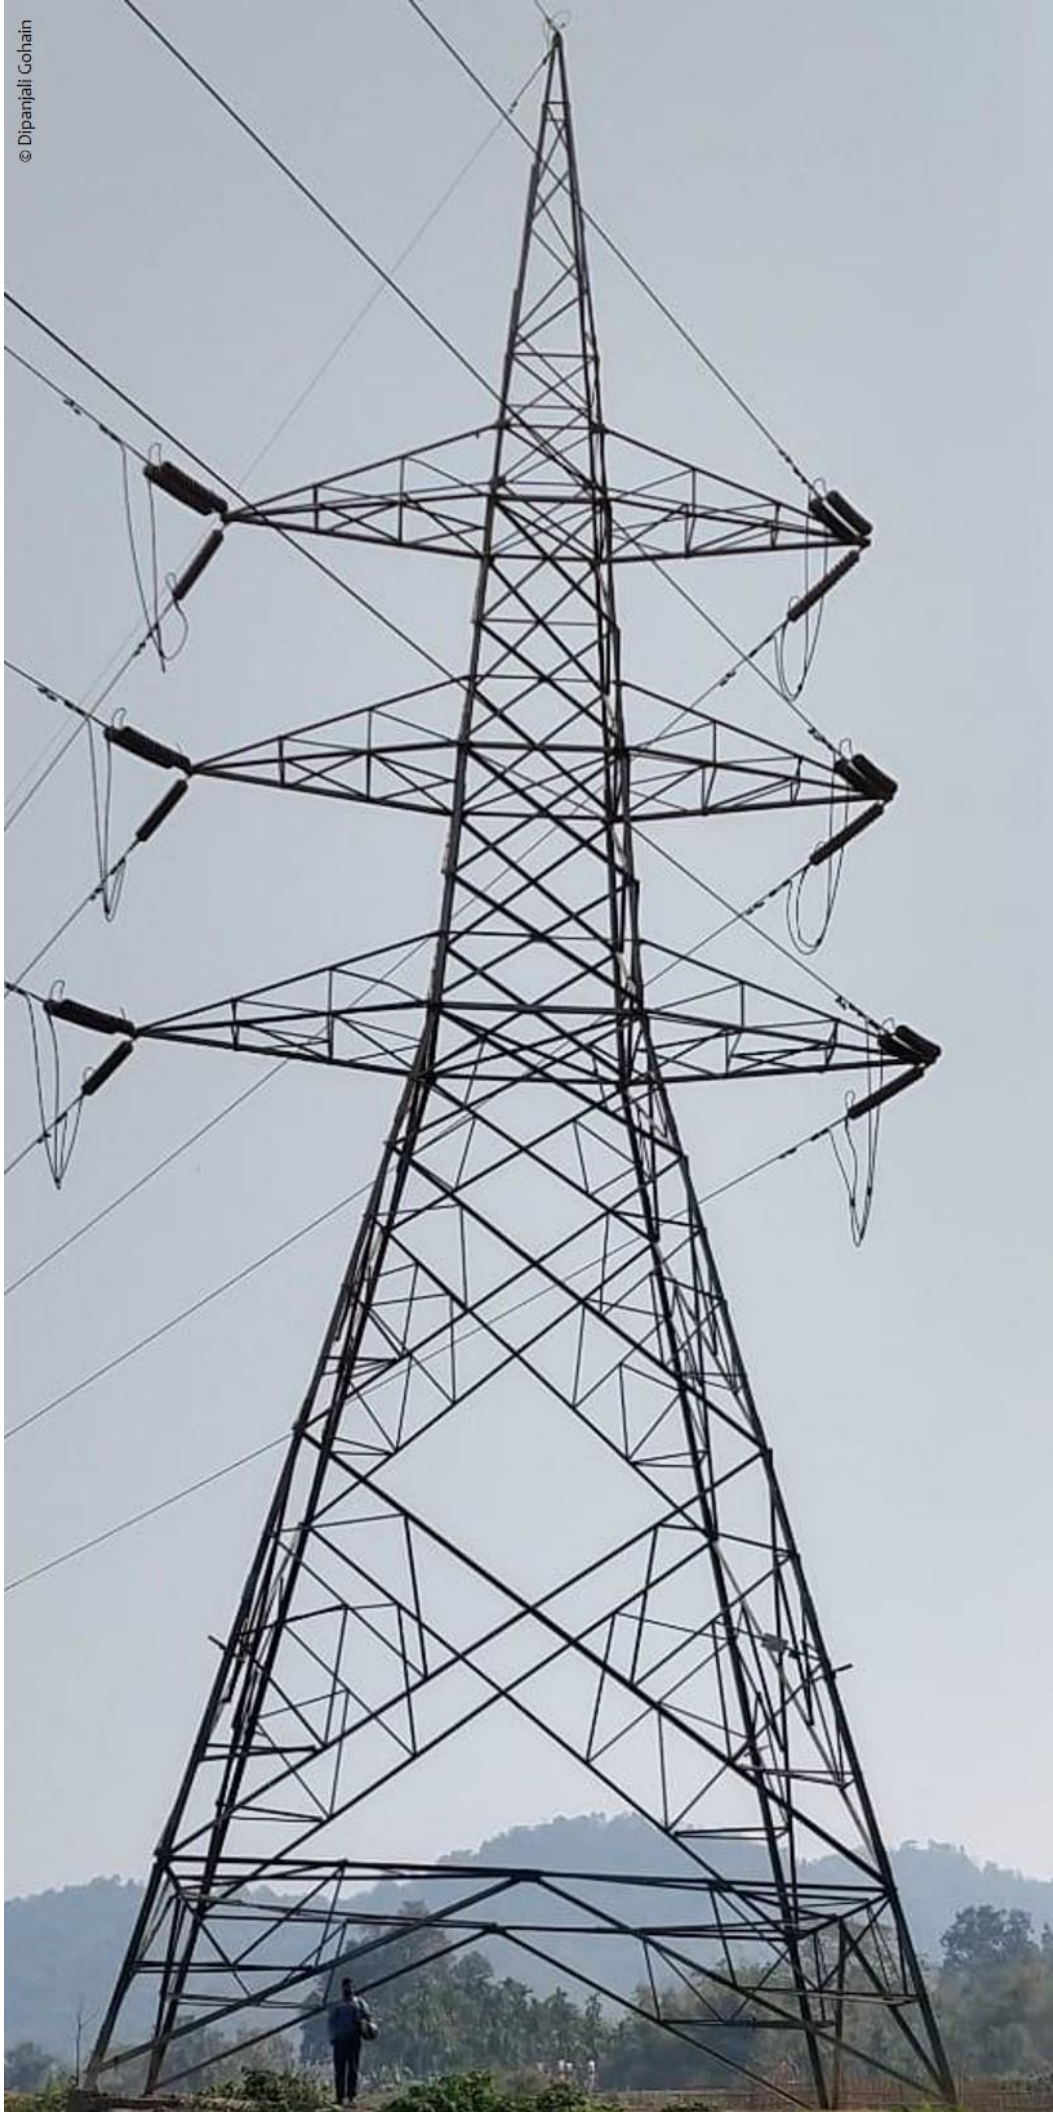
The 220 kV transmission line in the area has three phase wires on either side of the pylon and was well separated and as a result do not pose electrocution risk, while pose the risk of collision to birds in flight

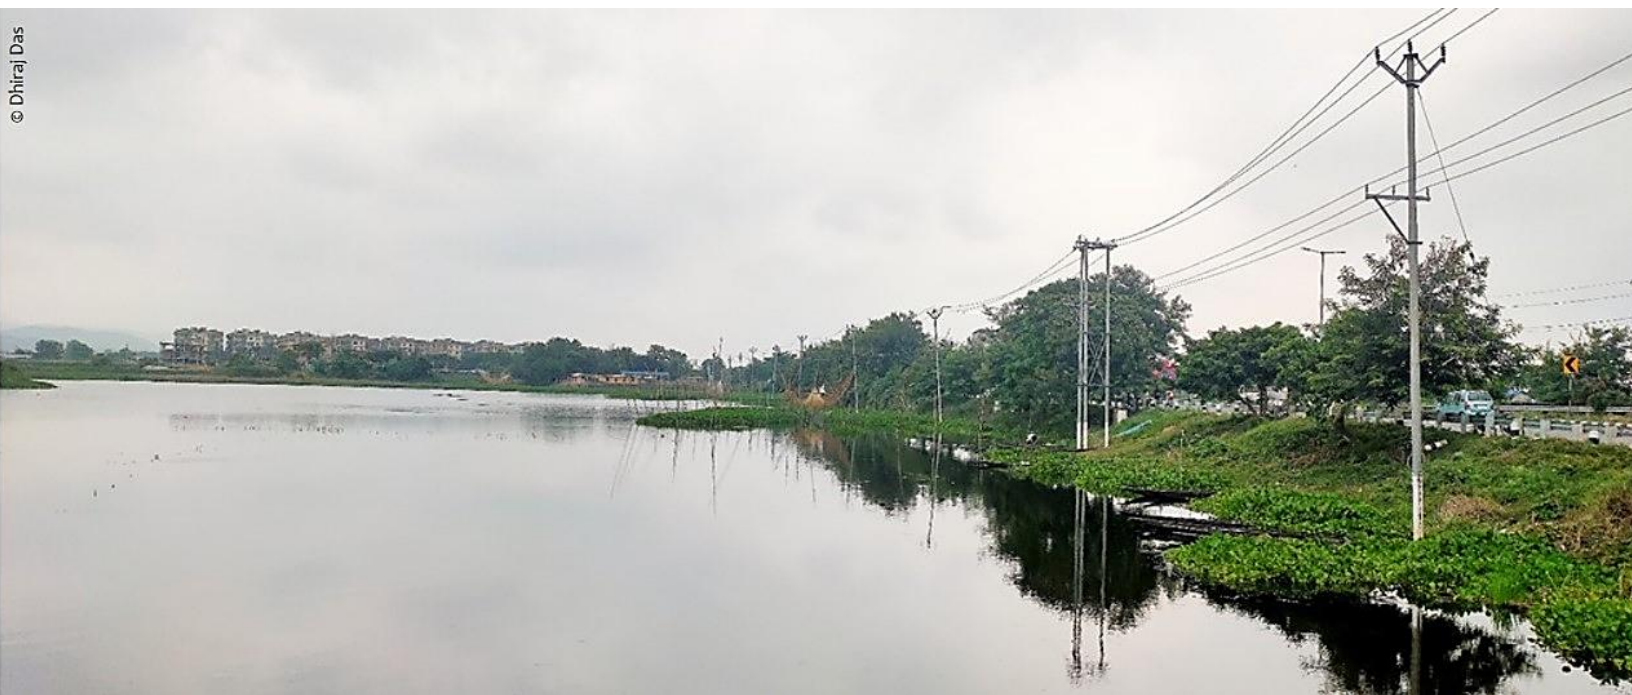
Figure 3. A map of the Deepor Beel Ramsar Site showing the existing power line network in the area that includes one 220 kV transmission line located along the southern boundary and a network of 30 distribution lines of both 11 kV and 33 kV.

For assessing collision risk to birds, the transmission line stretch from near to Azara railway station to the point near Boragaon disposal site spanning a length of 5.15 km was selected. This line stretch had 19 pylons and was demarcated into five spans with varying length (Figure 3). The line span 1 (900 m) and 3 (970 m) had three line sections, while span 2 (1380 m), span 4 (1160 m) and Span 5 (1070 m) had four line sections. The longest line span section was 420 m and this was over water and is part of span 1. The transmission line stretch beyond these spans were not included for the collision risk observations since during preliminary surveys very low bird activity was observed there, which was likely a result of presence of habitations and construction works.

The distribution lines as expected were relatively more in number and in all 30 lines spanning a total length of 41.19 km (11 kV) and 14.01 km (33 kV) in and around Deepor Beel was mapped and surveyed (Figure 3; Table 1). The distribution lines were primarily all along the roadside except for one 33 kV line (8.86 km) located along the southern fringe of the Beel that cut through forested tracts of the Rani-Garbhangra Reserve Forest in certain parts. The distribution lines in the area were predominantly with three phase wires held atop a single utility pole that was mostly metal, and the poles were on average 10 m in height. At line junctions, the number of utility poles were variable and ranged from 2 to 4. The three phase wires were held on pin insulators atop a metal cross arm, and in few cases from suspended insulators. On few poles, additional phase wires were observed below the main cross arm.
