ACTION HISTORY OF RTI REQUEST No.WLIOI/R/E/21/00071

Deepor Beel Railway Track Mitigation Plan

TR No. 2021/12

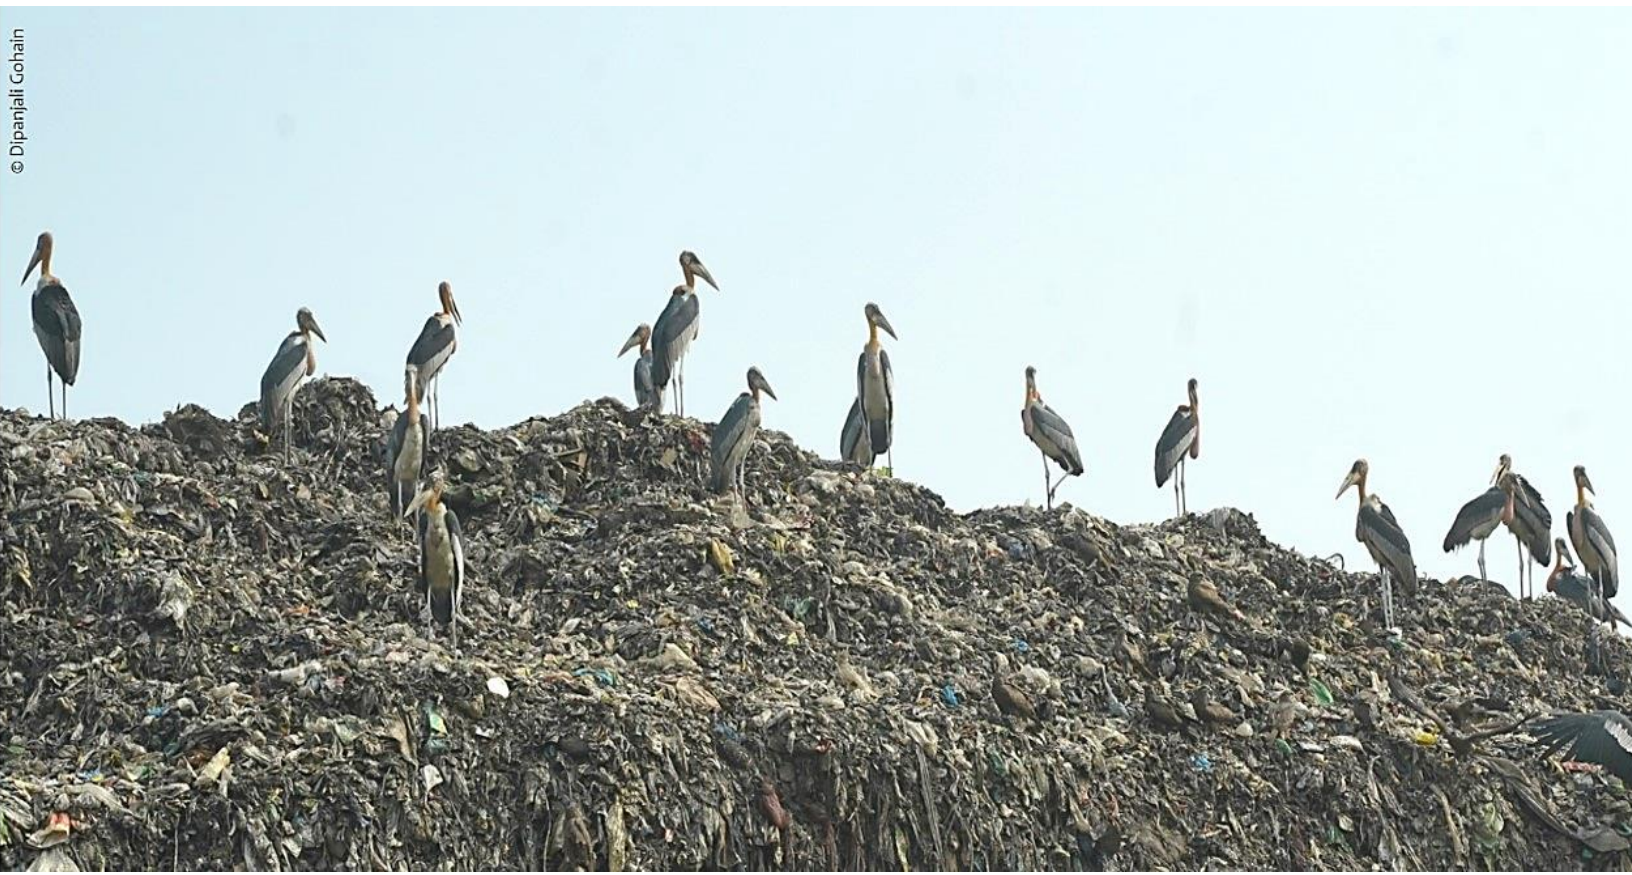
Figure 4. The species richness, overall average abundance of both waterbirds and water associate species across the Deepor Beel wetland along with the Simpson's Evenness Index were found to be markedly different between and among the two species groups indicating differences in their use of the area.

An average Simpson's Evenness Index (SEI) of the grids sampled showed waterbirds and water associate species together with their populations to be variable, further signifying certain areas across the Beel to be more important than others (Figure 4 & 5). The interquartile range in the case of waterbirds was widest in the Grid # 4, 5 & 8 as on many of the sampling sessions either only few or no birds were recorded there. In Grid # 4 & 5 relatively high human disturbance due to the presence of the Azara-Garchuk road and habitations, along with tourism activity likely influenced waterbirds there. In Grid # 8 much of the area is dry land with shrub cover and the rest was covered with water hyacinth, not a suitable habitat of waterbirds. Similarly, in the case of water associates, Grid # 8, 17 & 19 with 8, 12 & 14 species respectively had wide inter-quartile range. Many of the species recorded there were only seen on few occasions and in relatively low numbers. The Grid # 8 again appeared unsuitable for these birds and the few species that occurred there were only recorded sporadically. In Grid # 19 and 17 fishing activity by local people appears to have influenced water associate species presence.

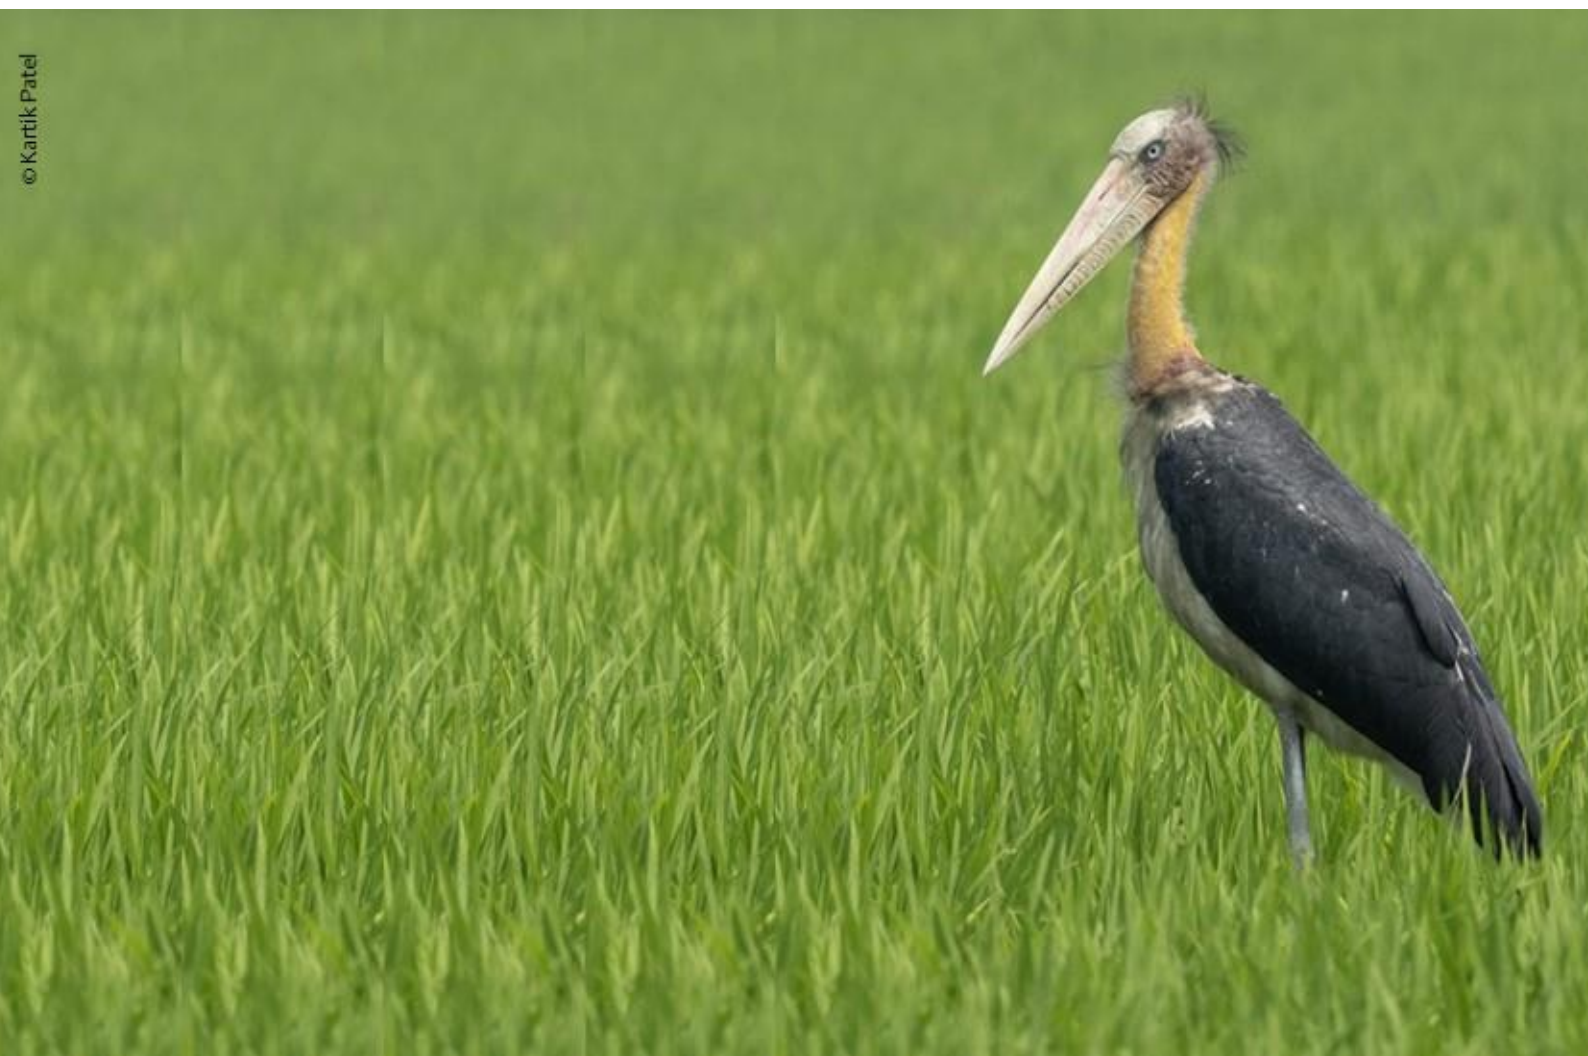
Figure 6. The sighting locations of the two Adjutant stork species recorded in and around Deepor Beel during the study along with the locations of 11 kV and 33 kV distribution line power poles that pose Very High/High electrocution risk to the species.

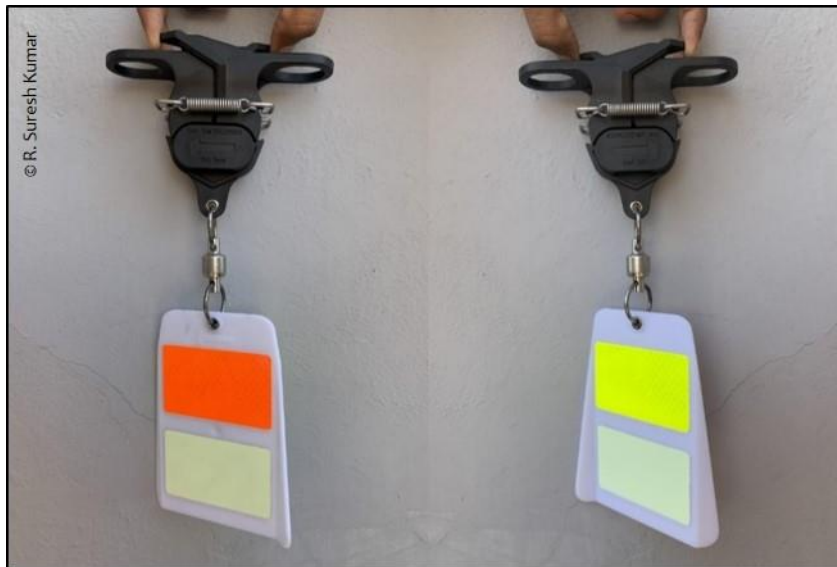
The glow in the dark suspended bird flight diverters are widely used around the world to mitigate the risk of bird collision

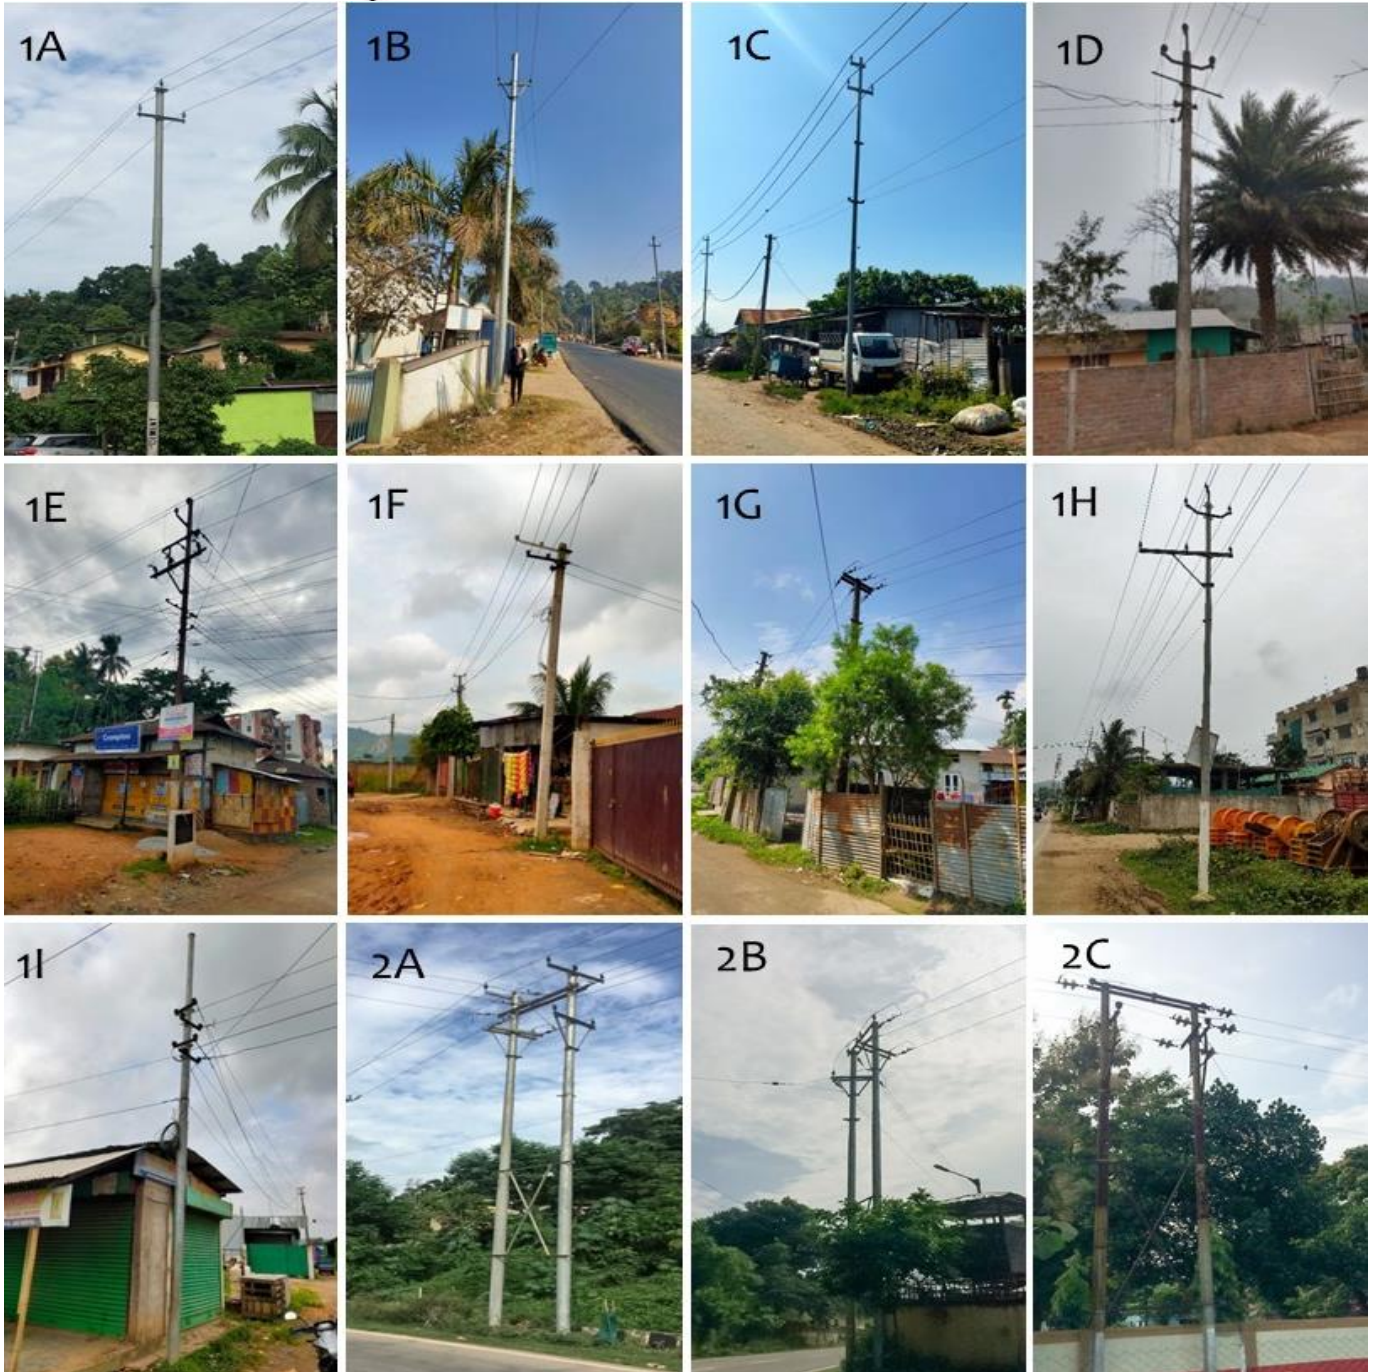
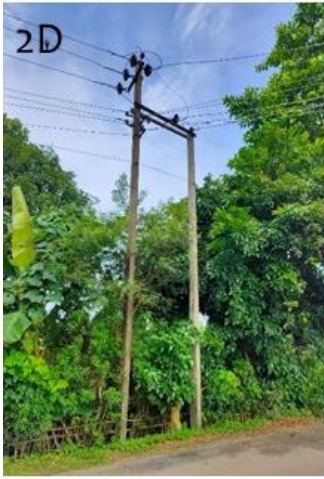
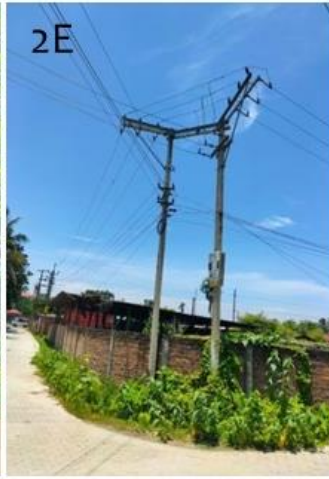
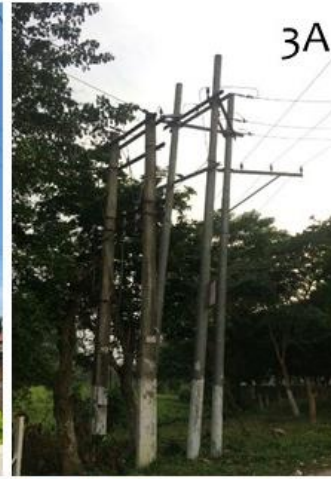
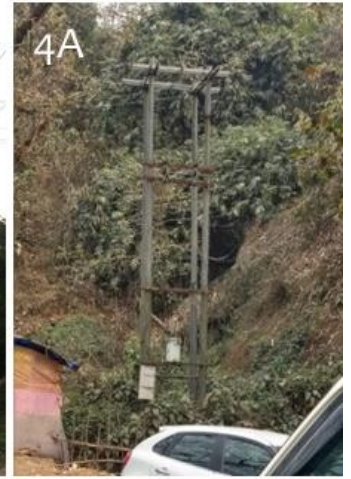
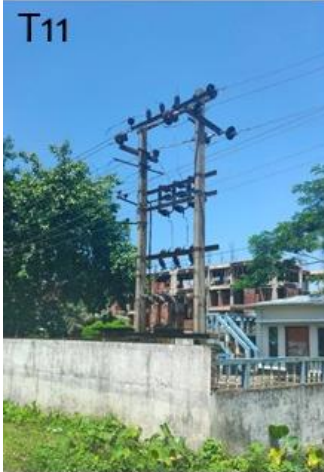
11 kV Distribution Line

Distribution line pole characteristics - The images below depict the structural differences in the poles of 11 kV and 33 kV distribution lines surveyed in and around Deepor Beel. The alpha-numeric codes on the image refers to whether it is single (1), double (2), triple (3) or quadra (4) pole type and the alphabet refers to individual types. In all 17 and 23 different pole types were seen in the 11 kV and 33 kV respectively.
