**Sub: - Proposal for Tinaighat- Castlerock-Caranzol doubling of railway line by South Western Railways, Karnataka [Original Agenda Item No 58.5.1] Recommendations of the Standing Committee of National Board for Wild Life in 59th Meeting-Reg.**

**Figure 1:** Mitigation measures recommended on the existing and proposed railway tracks in the Tinaighat to Castlerock segment (Chainage 12/000 to 25/000)

## **CHAPTER 3: Mitigation Measures for the doubling of the Tinaighat-Castlerock-Caranzol SWR Railway Track**

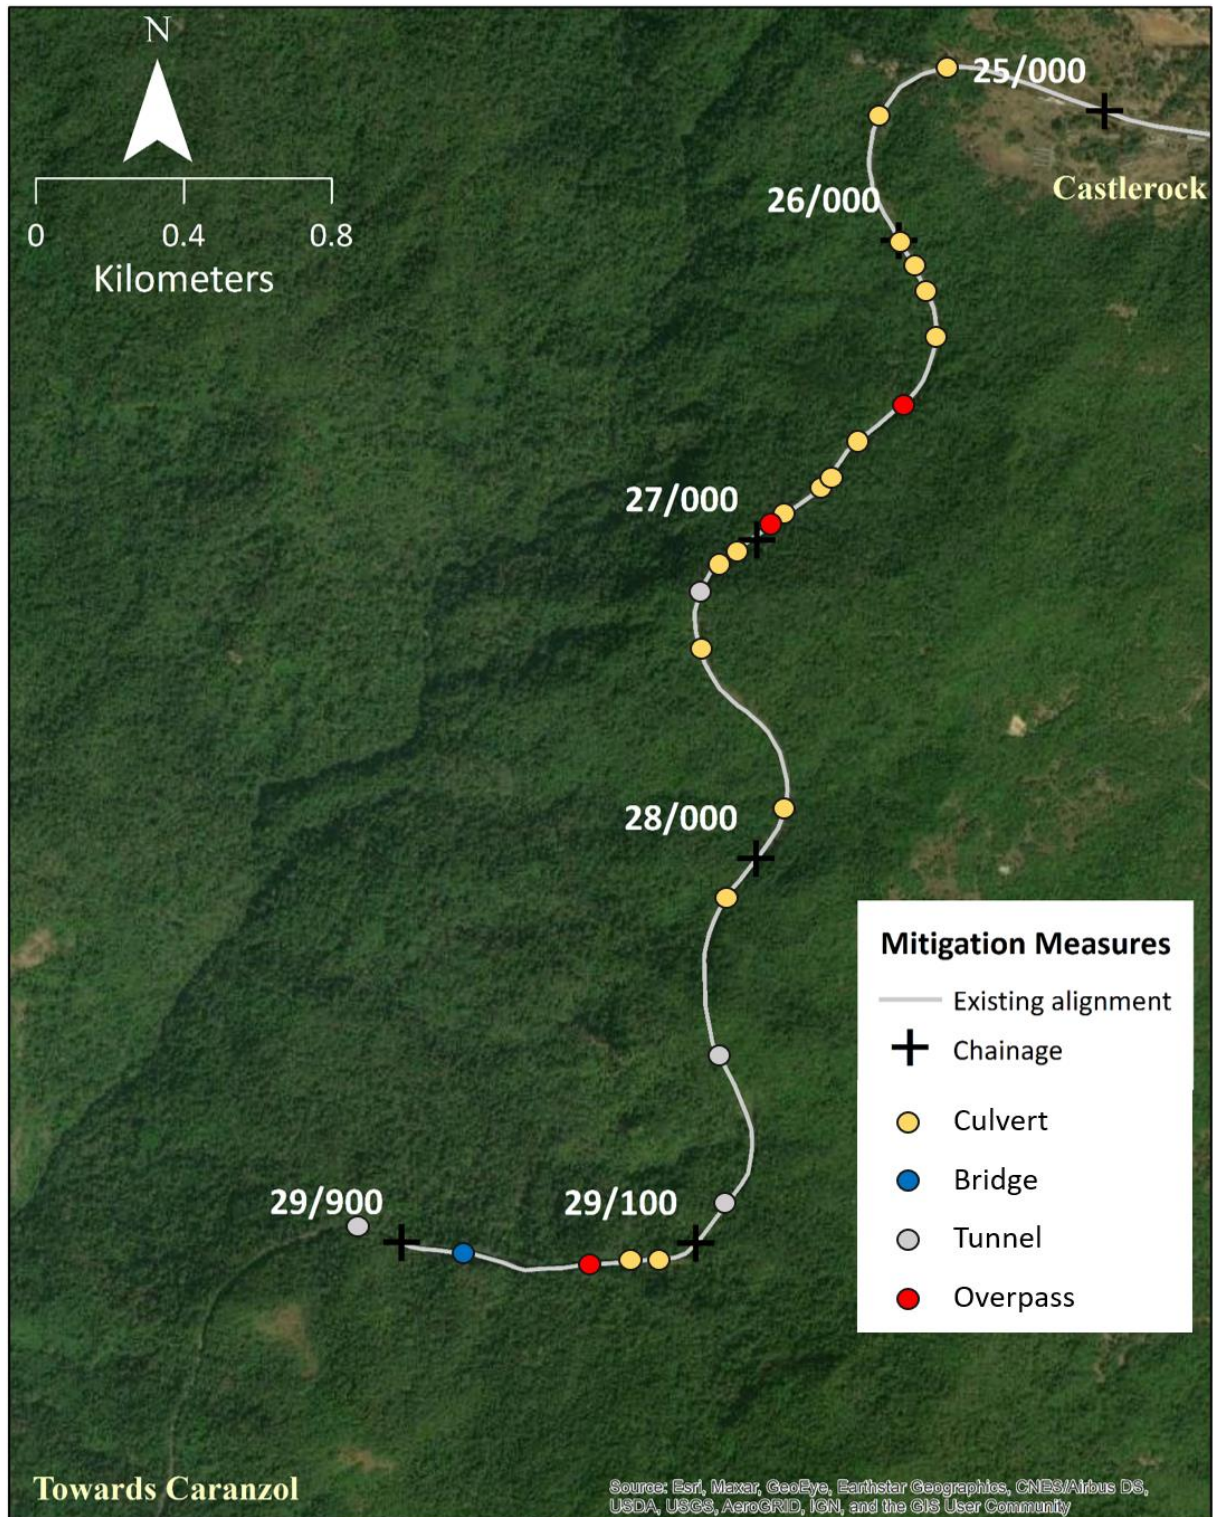
Figure 2: Mitigation measures recommended on the existing and proposed railway tracks in the Castlerock-Caranzol segment (Chainage 25/000 to 29/900)

Given below are details of the proposed mitigation measures on the existing and proposed railway track (Tables 1 & 2; Figures 1 & 2). It is important to assert that the recommended measures are to be implemented on both the existing and the proposed railway track for the measures to be effective. Once the mitigation measures are completed on the new track, railways can initiate the construction of mitigation measures on the existing track in a phased manner. Areas between mitigation measures need to be fenced to avoid animal hits by rail, and to funnel animals towards the mitigation measures. This would also discourage animals from entering the railway track.

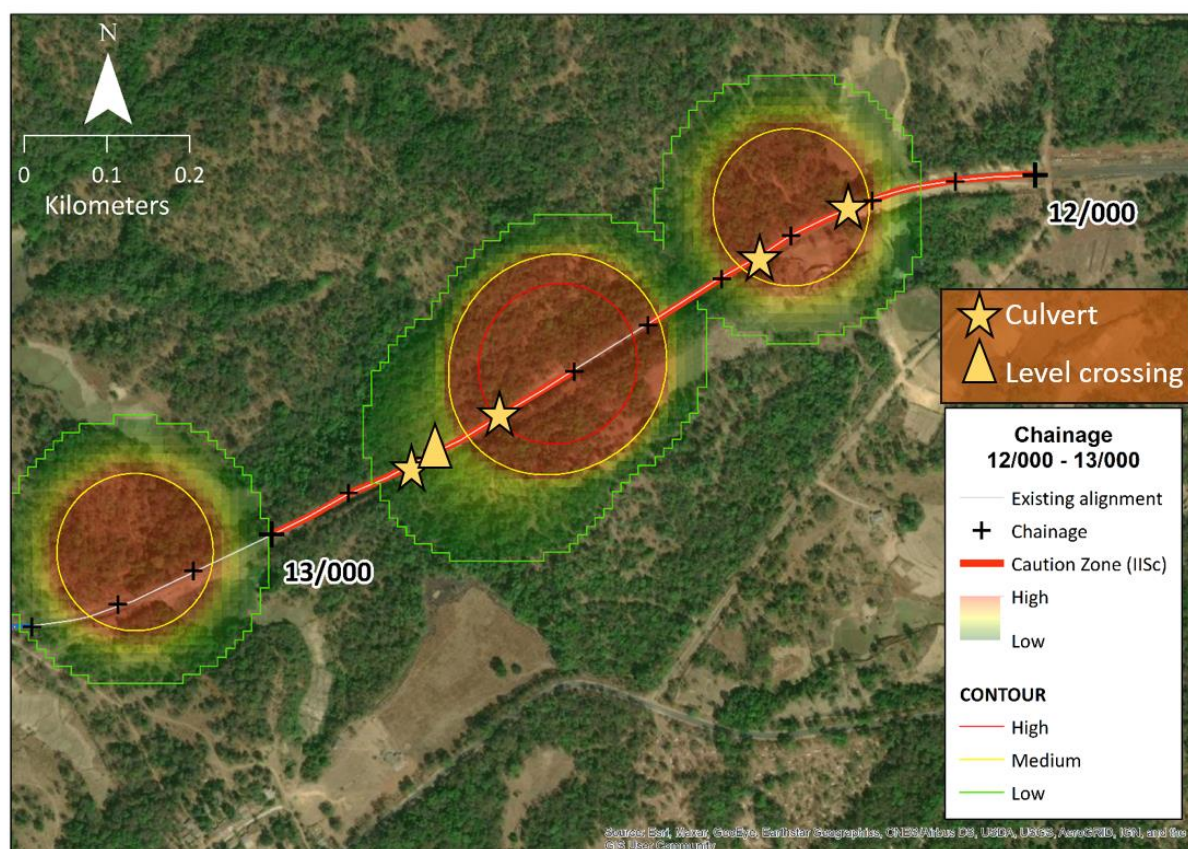
**Figure 28:** Locations of mitigation measures on chainage 12/000 – 13/000 to be constructed on existing and proposed railway track (NOTE: locations are approximated to the nearest chainage).

Increase in dimensions with ledges for structures 1 and 2 is recommended to make the structures more suitable for use by animals. Ledges are to be provided within all crossing structures.

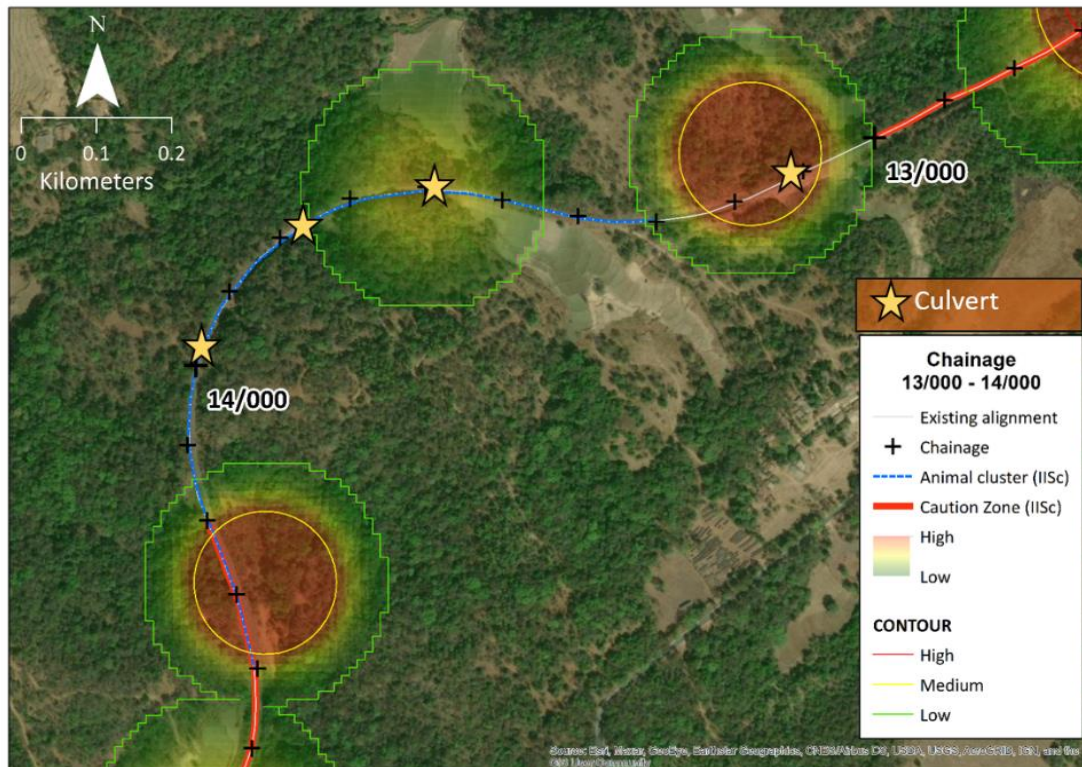
**Figure 29:** Locations of mitigation measures on chainage 13/000 – 14/000 to be constructed on an existing and proposed railway track  
(NOTE: locations are approximated to the nearest chainage).

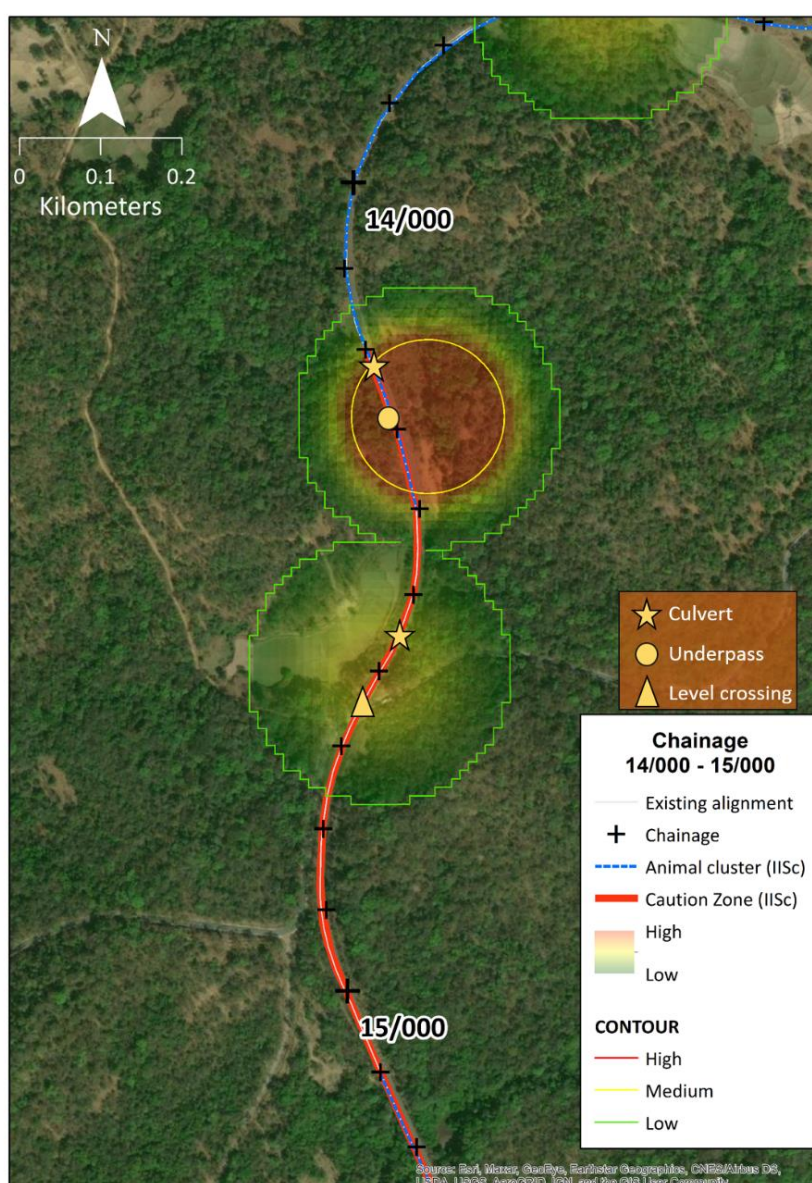
**Figure 30:** Locations of mitigation measures on chainage 14/000 – 15/000 to be constructed on existing and proposed railway track  
(NOTE: locations are approximated to the nearest chainage).

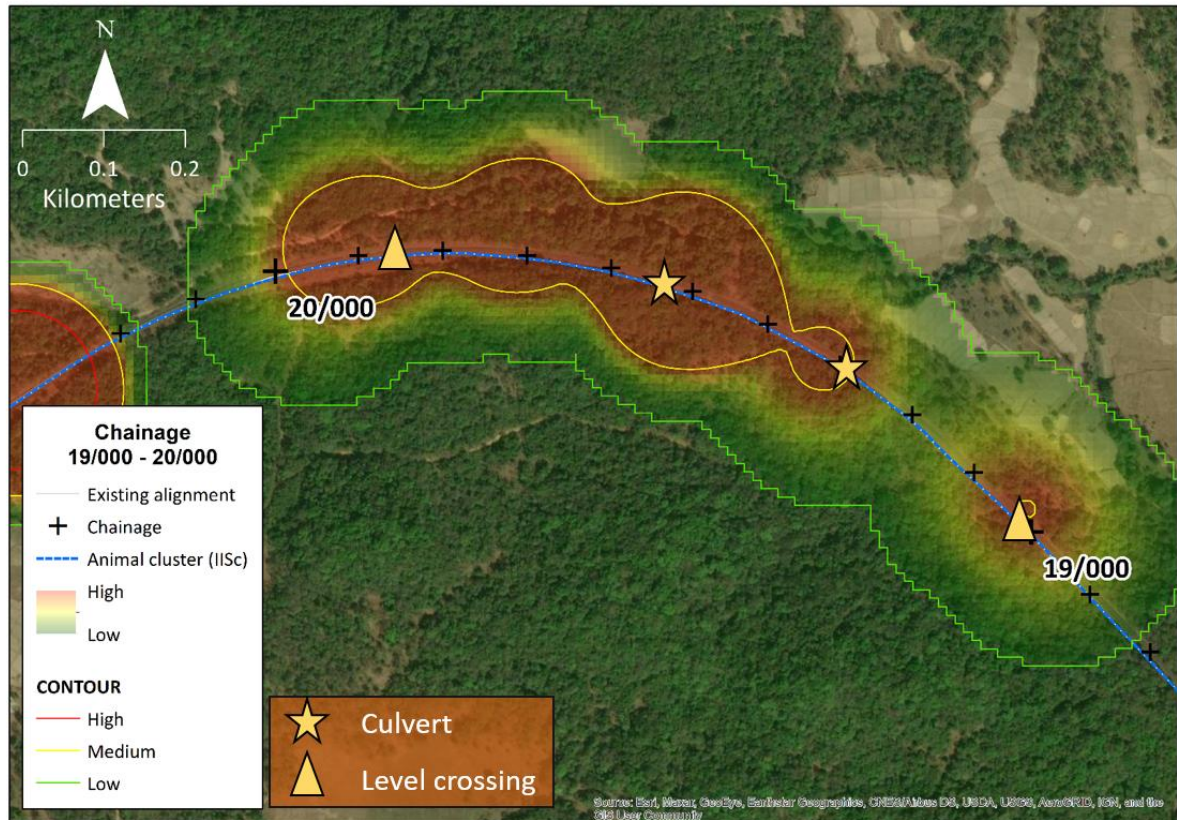
**Figure 35:** Locations of mitigation measures on chainage 19/000 – 20/000 to be constructed on existing and proposed railway track  
(NOTE: locations are approximated to the nearest chainage).

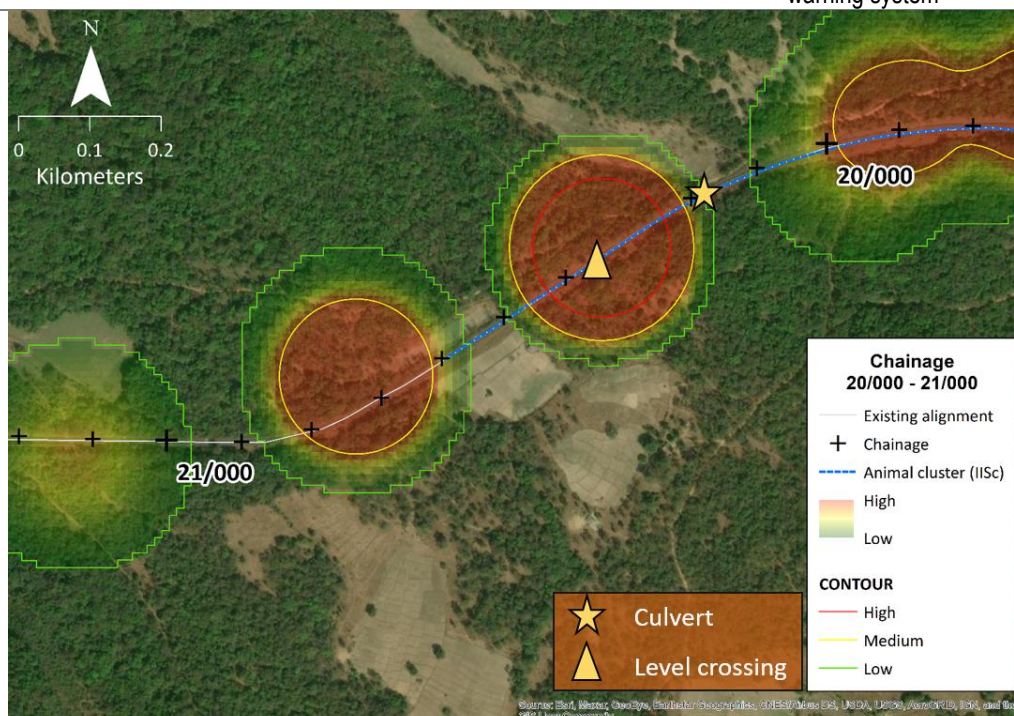
**Figure 36:** Locations of mitigation measures on chainage 20/000 – 21/000 to be constructed on existing and proposed railway track  
(NOTE: locations are approximated to the nearest chainage).

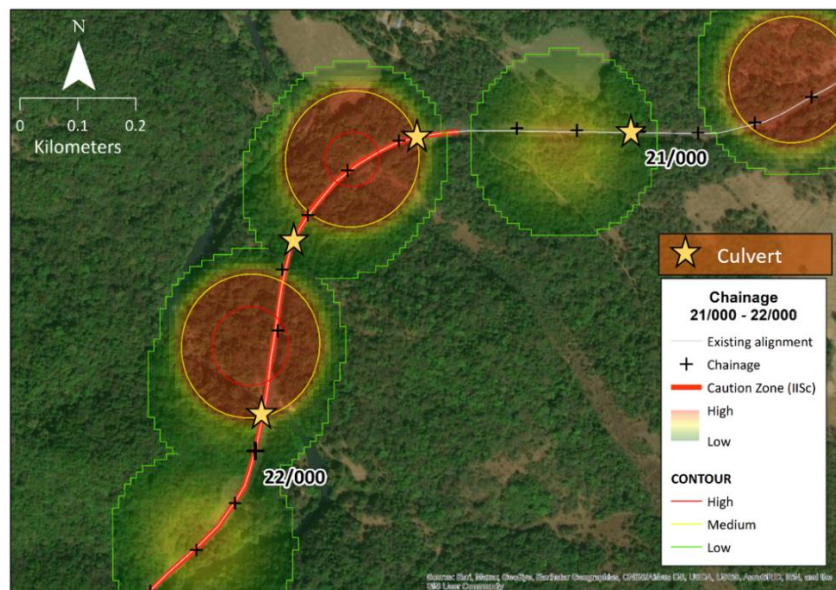
**Figure 37:** Locations of mitigation measures on chainage 21/000 – 22/000 to be constructed on existing and proposed railway track  
(NOTE: locations are approximated to the nearest chainage).

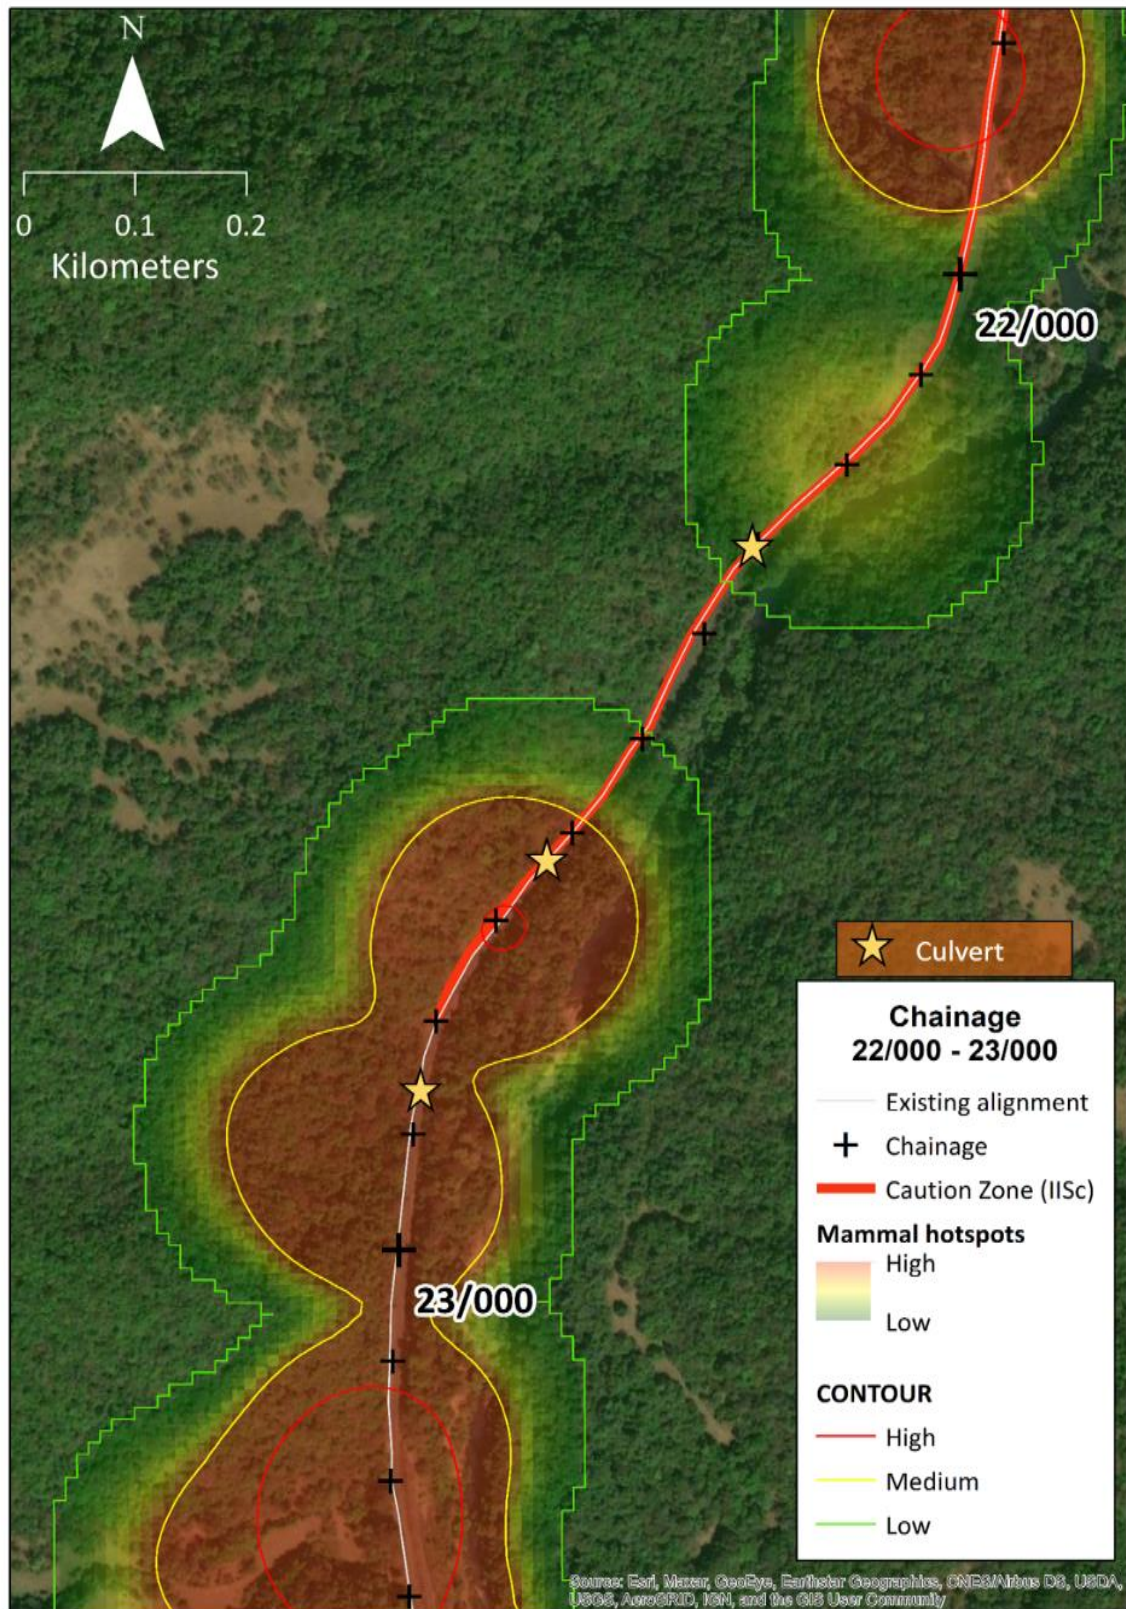
**Figure 38:** Locations of mitigation measures on chainage 22/000 – 23/000 to be constructed on existing and proposed railway track  
(NOTE: locations are approximated to the nearest chainage).

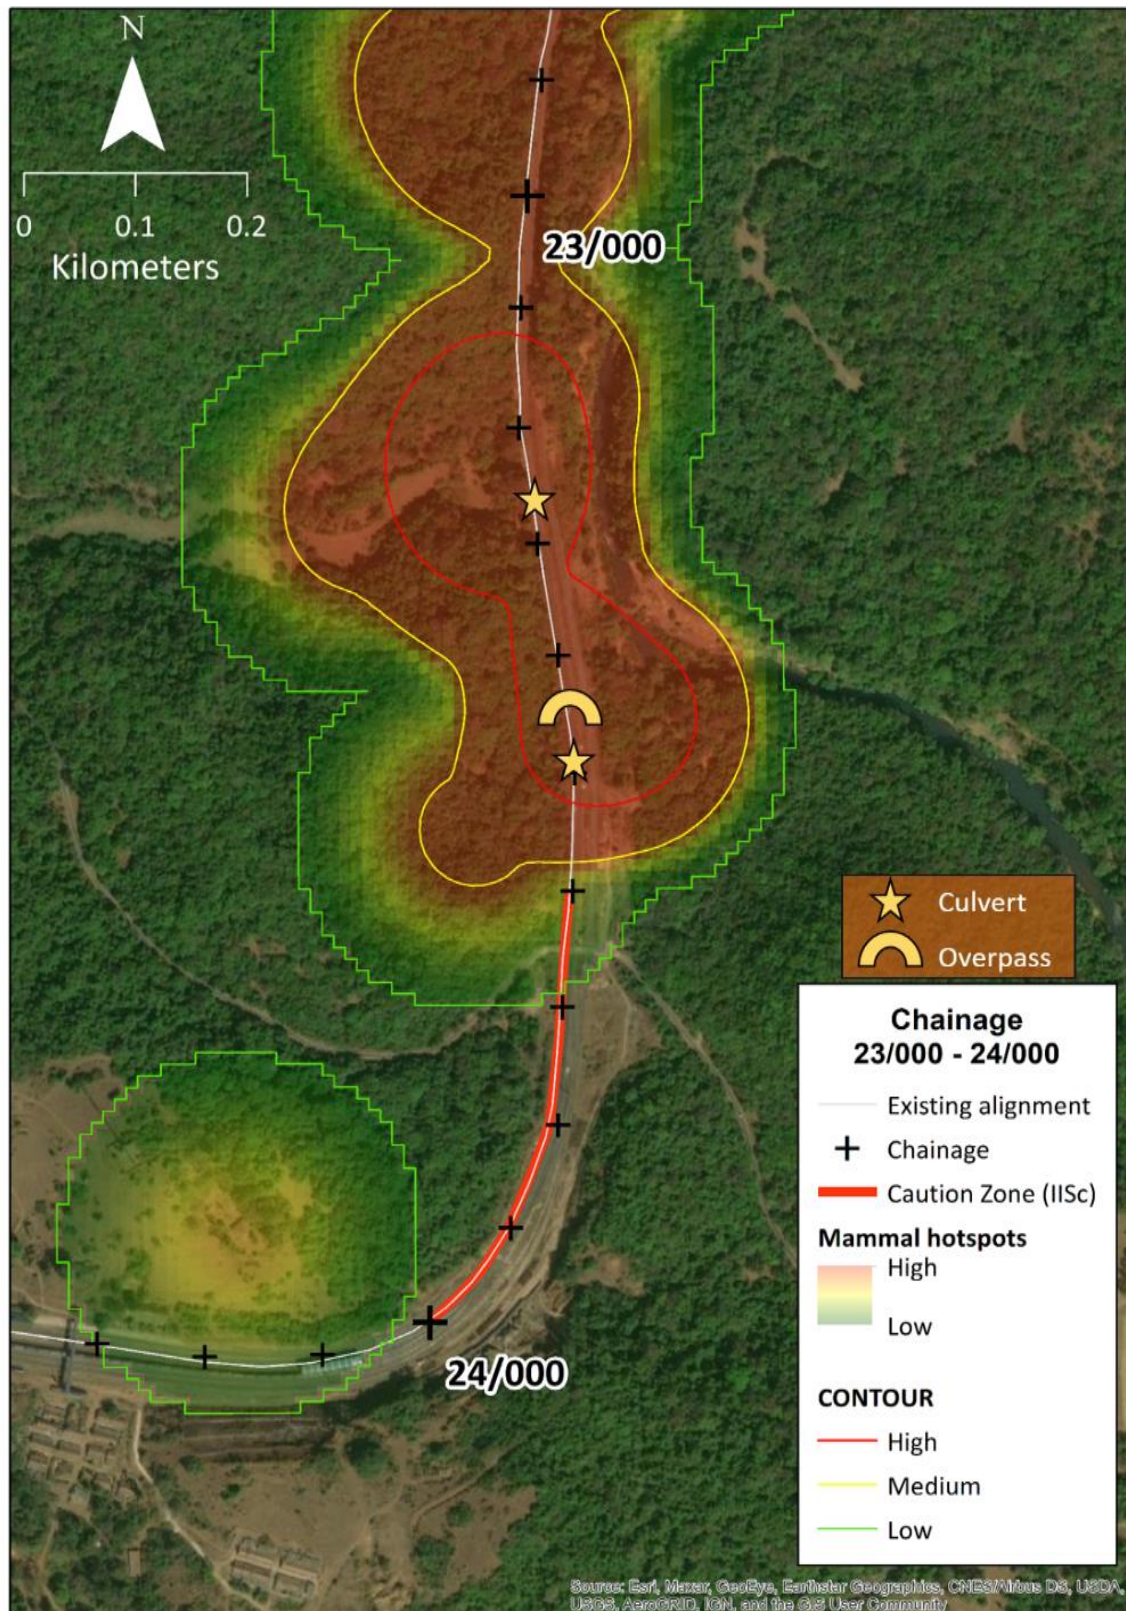
**Figure 39:** Locations of mitigation measures on chainage 23/000 – 24/000 to be constructed on existing and proposed railway track  
(NOTE: locations are approximated to the nearest chainage).

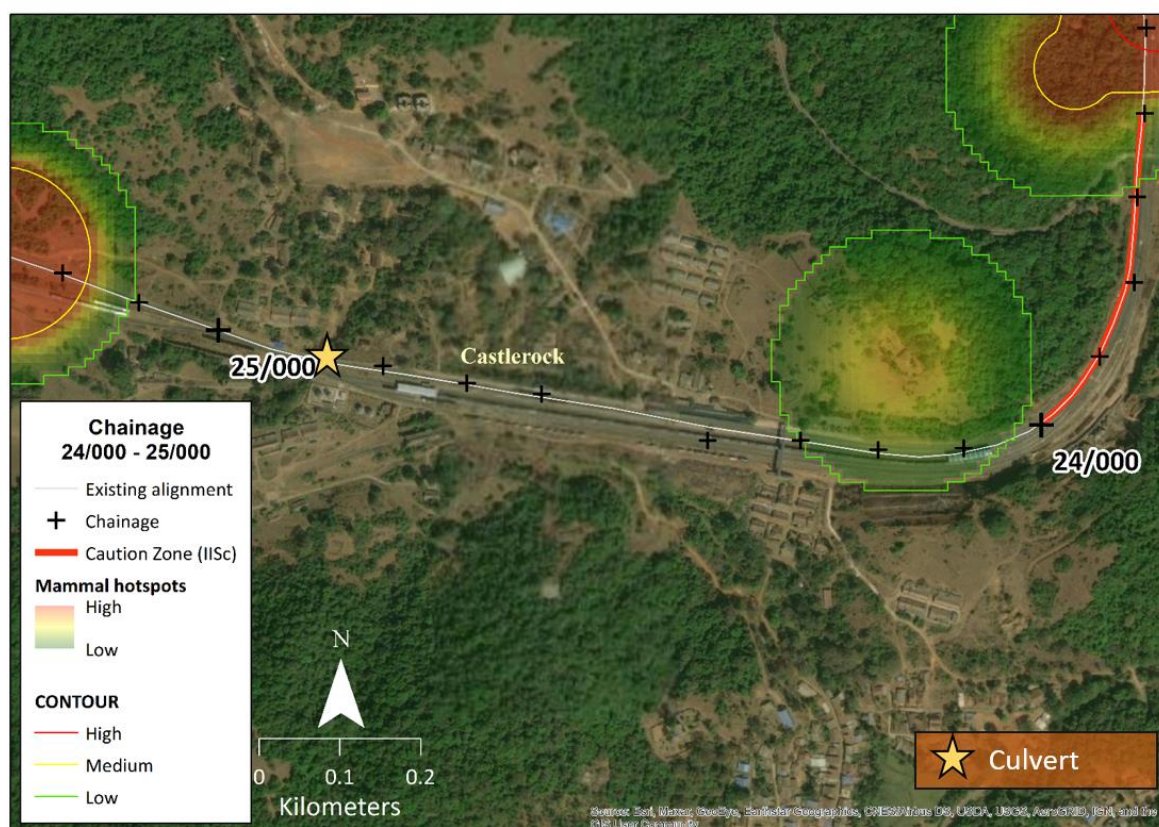
**Figure 40:** Locations of mitigation measures on chainage 24/000 – 25/000 to be constructed on existing and proposed railway track  
(NOTE: locations are approximated to the nearest chainage).

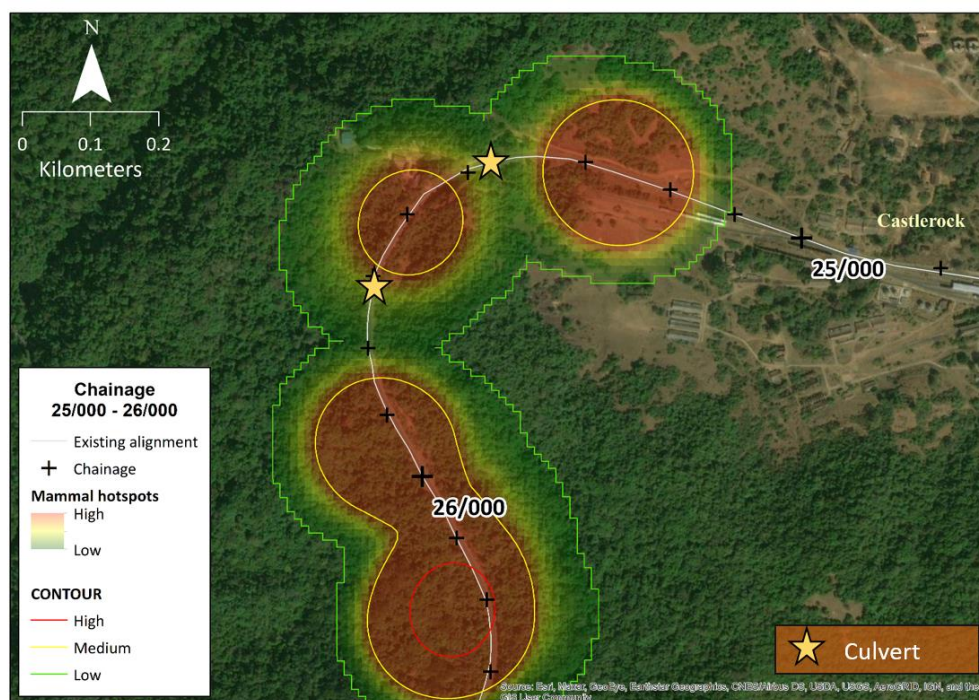
**Figure 41:** Locations of mitigation measures on chainage 25/000 – 26/000 to be constructed on existing and proposed railway track  
(NOTE: locations are approximated to the nearest chainage).

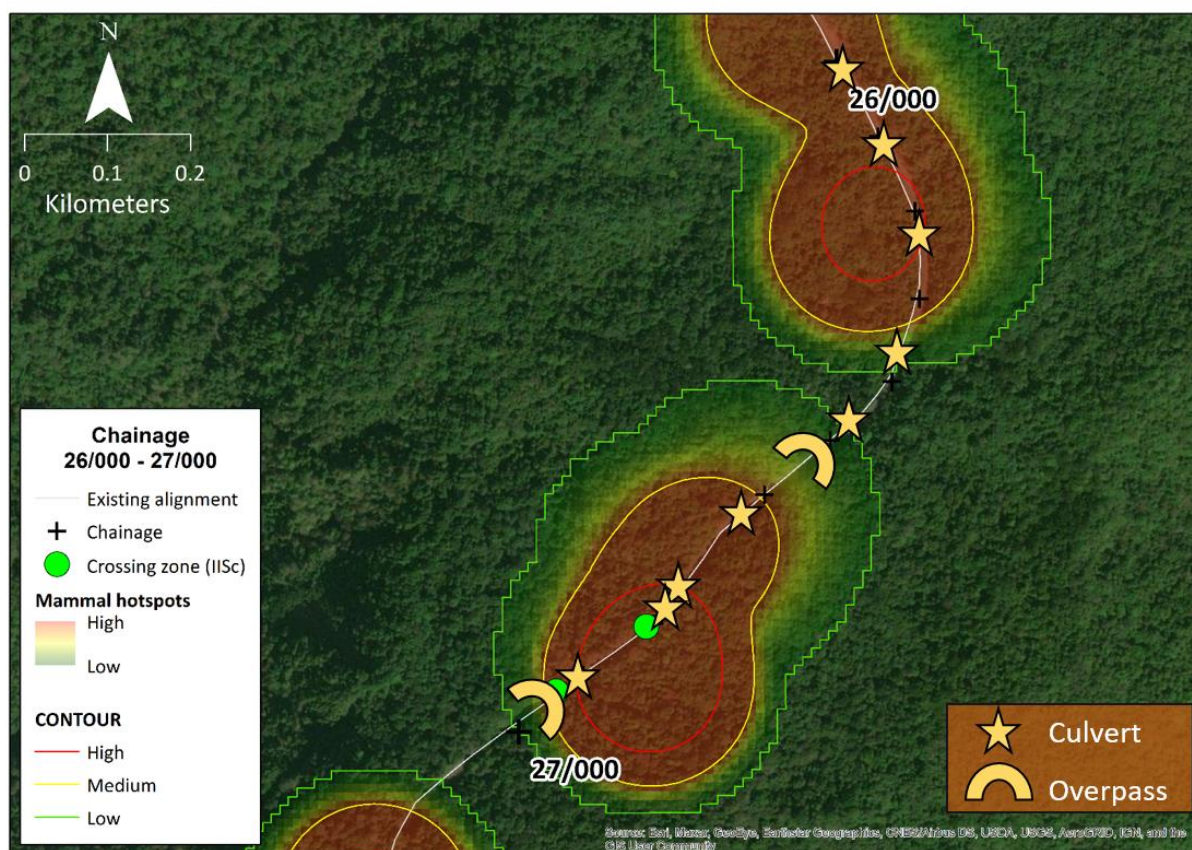
**Figure 42:** Locations of mitigation measures on chainage 26/000 – 27/000 to be constructed on existing and proposed railway track  
(NOTE: locations are approximated to the nearest chainage).

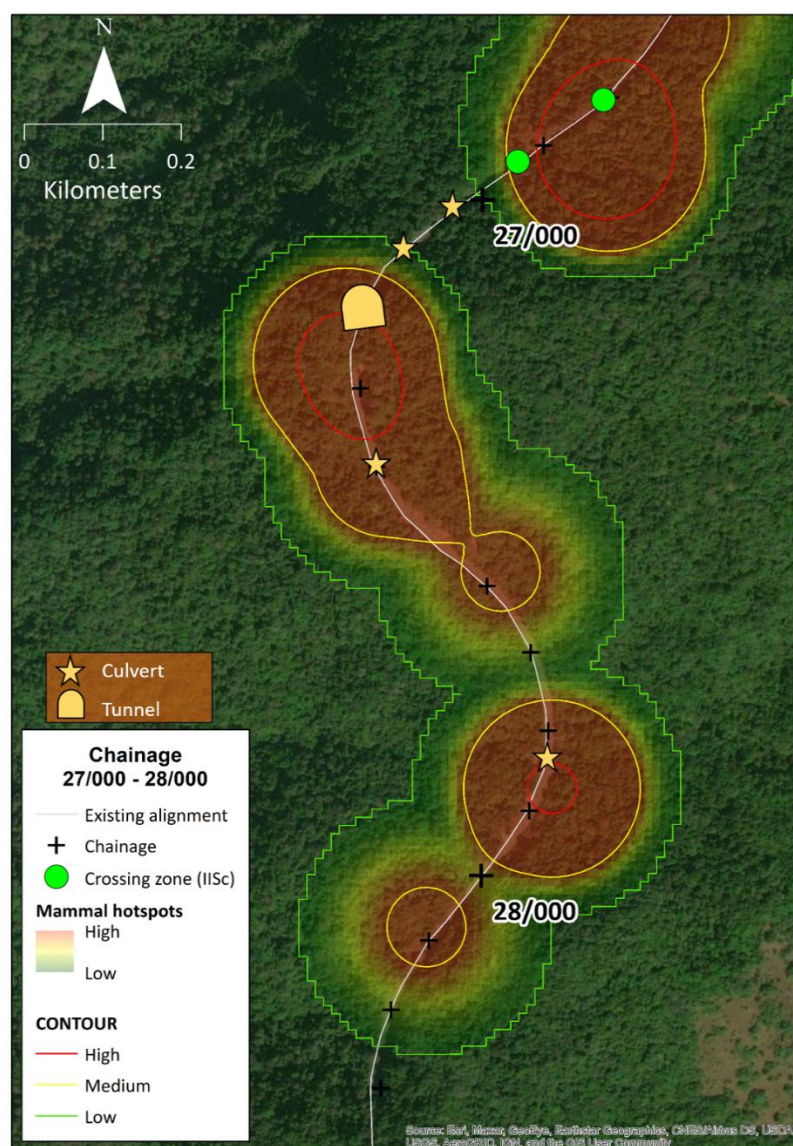
**Figure 43:** Locations of mitigation measures on chainage 27/000 – 28/000 to be constructed on existing and proposed railway track (NOTE: locations are approximated to the nearest chainage).

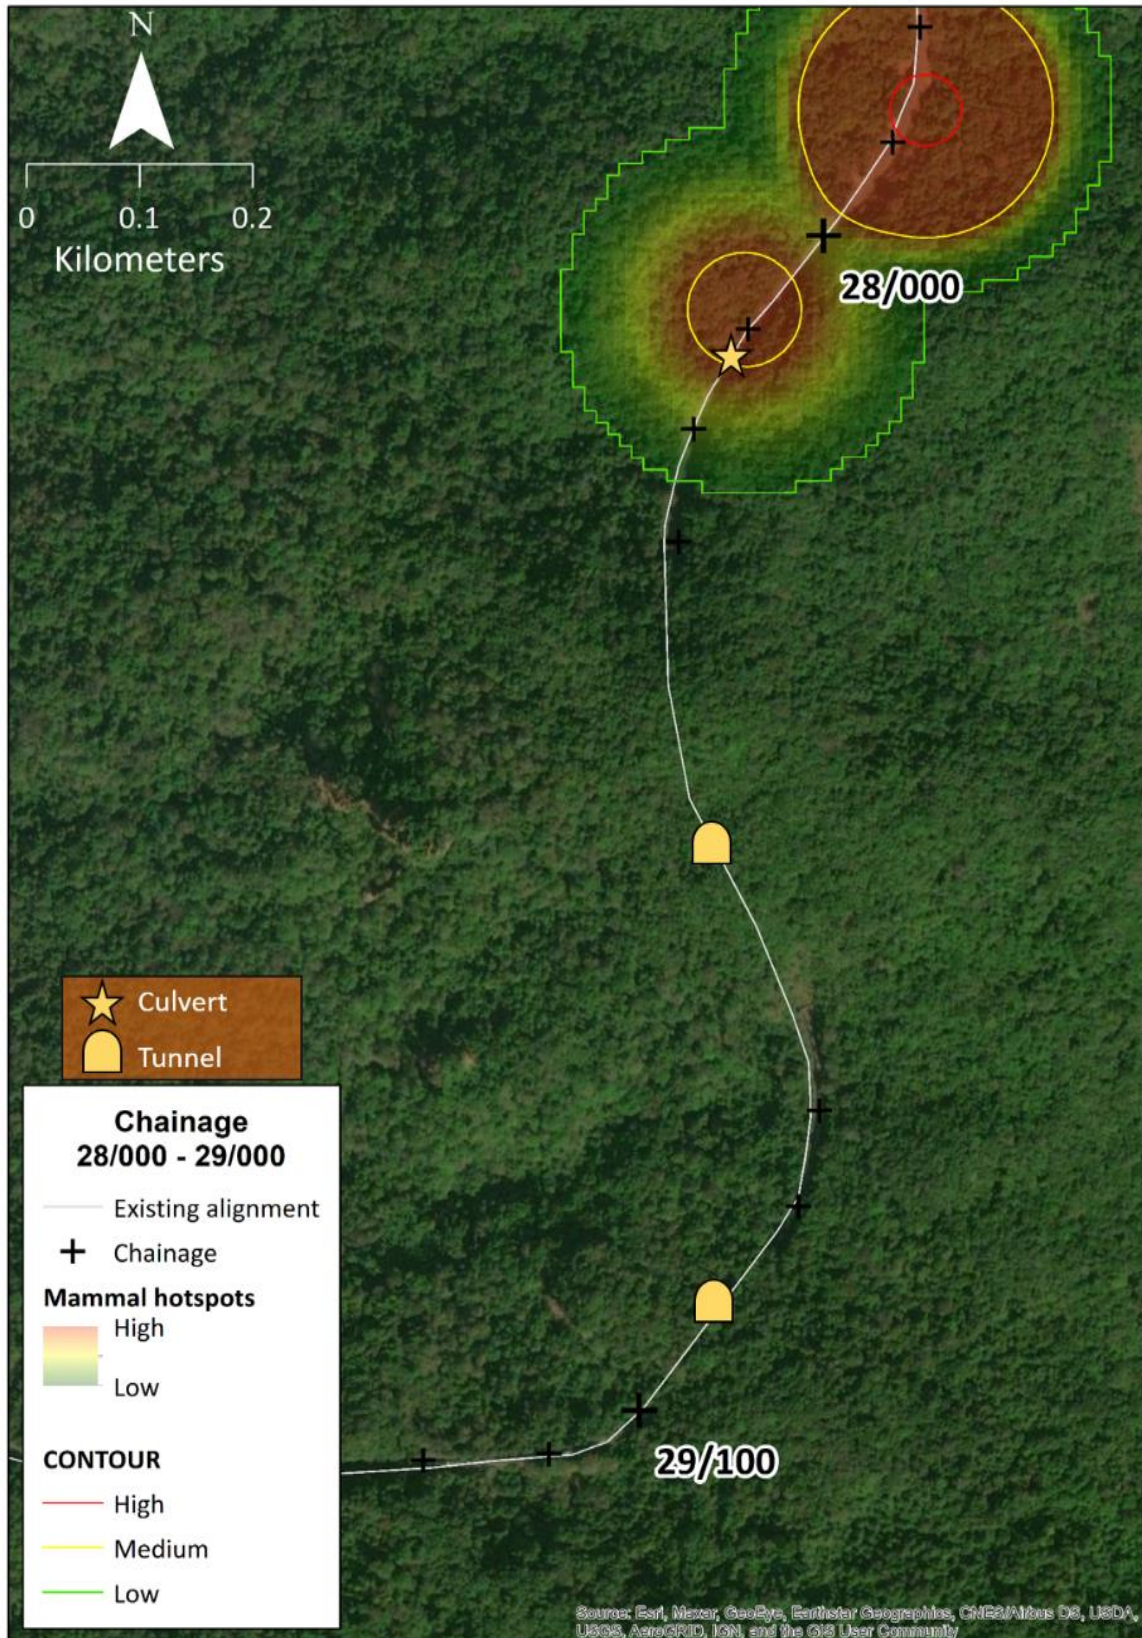
**Figure 44:** Locations of mitigation measures on chainage 28/000 – 29/000 to be constructed on existing and proposed railway track  
(NOTE: locations are approximated to the nearest chainage).

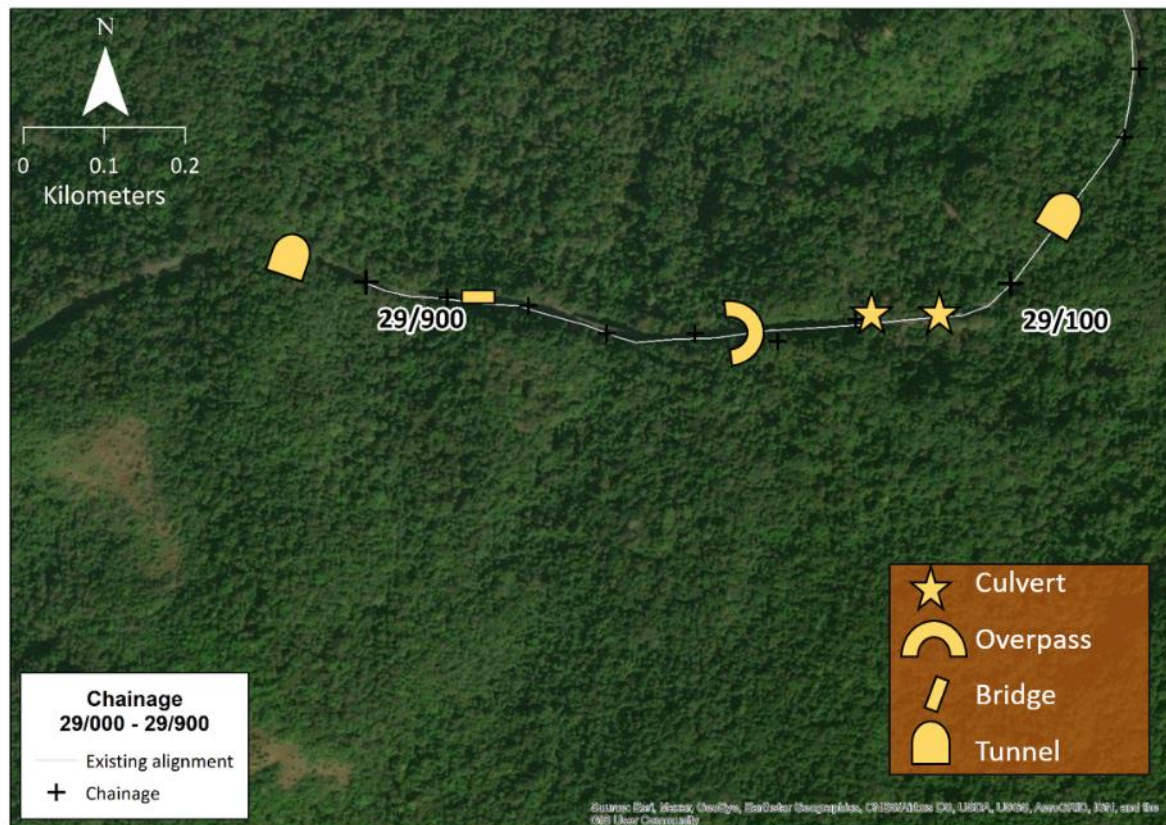
**Figure 45:** Locations of mitigation measures on chainage 29/000 – 29/900 to be constructed on existing and proposed railway track  
(NOTE: locations are approximated to the nearest chainage).

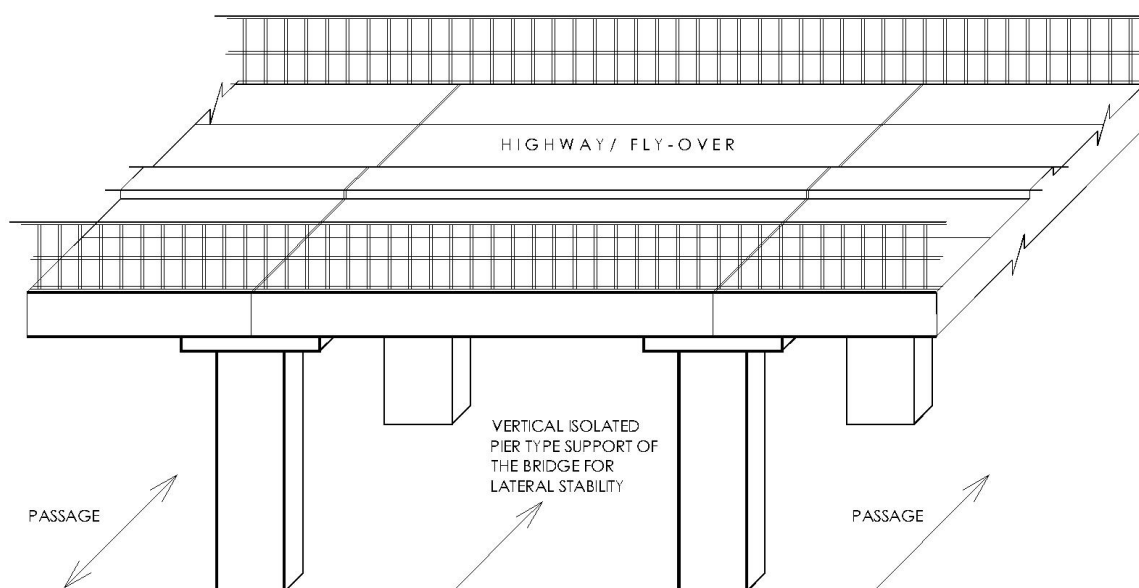
**Figure 46:** Pillar-type divisions are to be used for culverts instead of wall-type divisions  
(Source: WII, 2016)

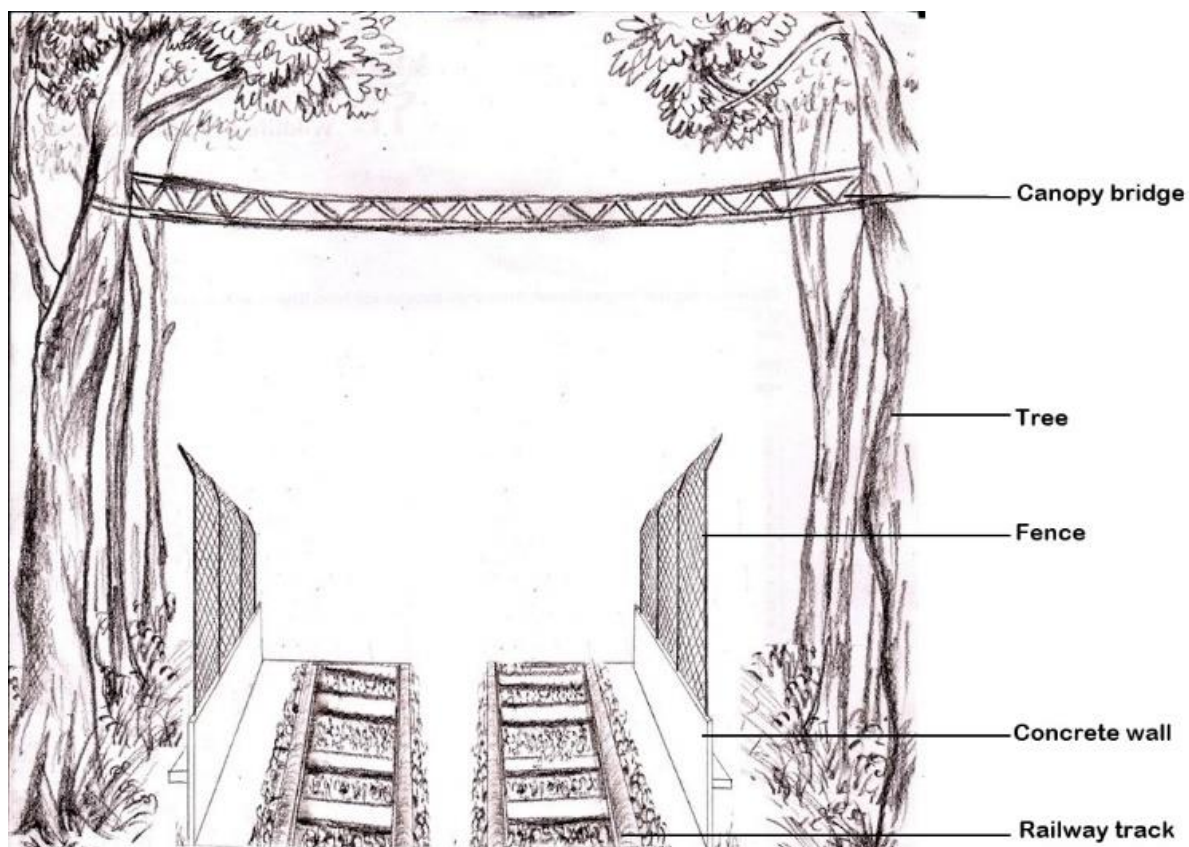
**Figure 48:** Canopy bridge design to be built across the doubled railway track for arboreal mammals.

To enhance connectivity for arboreal species in the landscape, provision of canopy bridges has been recommended at every kilometer of the railway track.

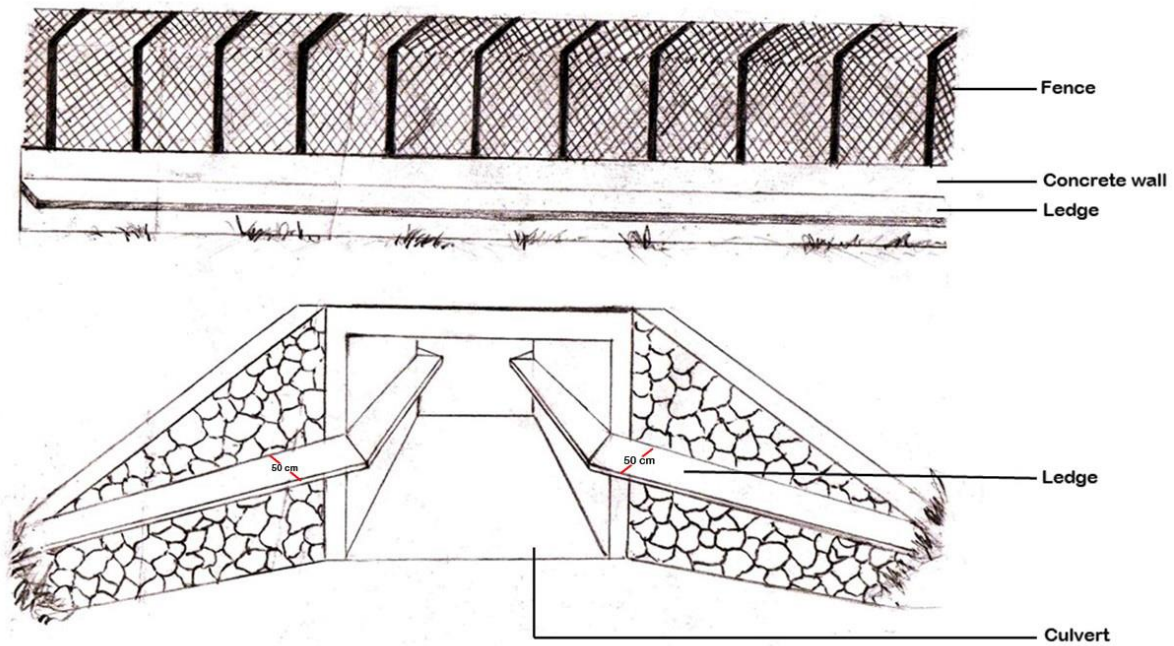
**Figure 49:** A. Ledges or shelves measuring 50 m wide are to be installed in all crossing and drainage structures. The ends of the shelves should be brought to ground level and fencing along the railway track should continue above all below-grade structures.

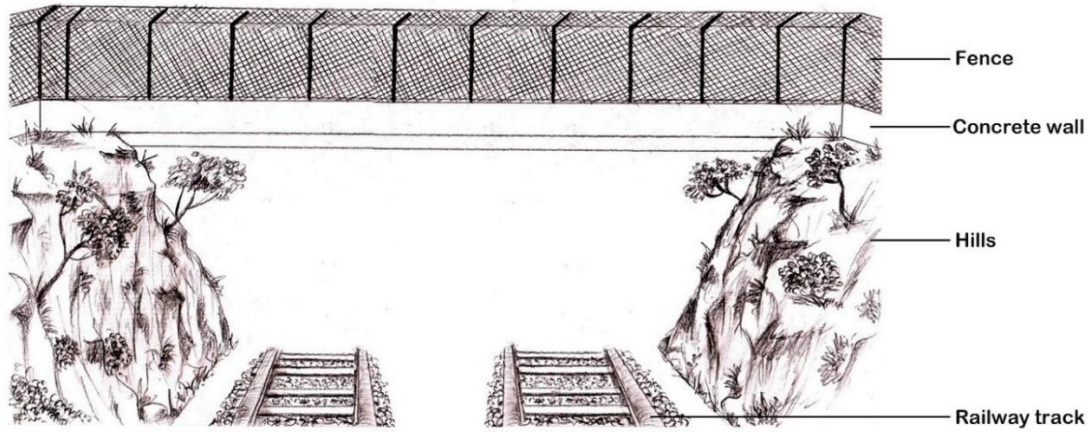
Figure 50 (a): Lateral view of overpass and adjoining features

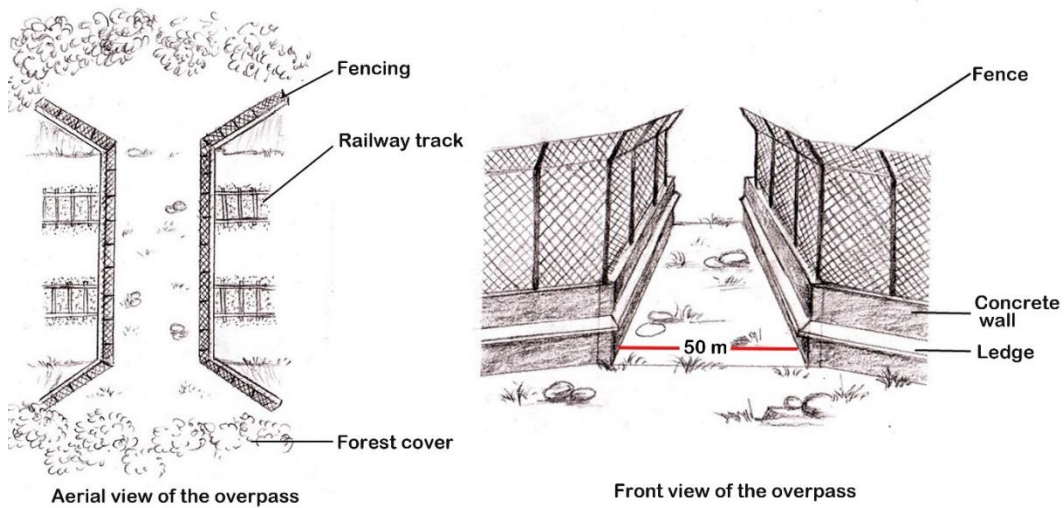
Figure 50 (b): Aerial and frontal view of the overpass.

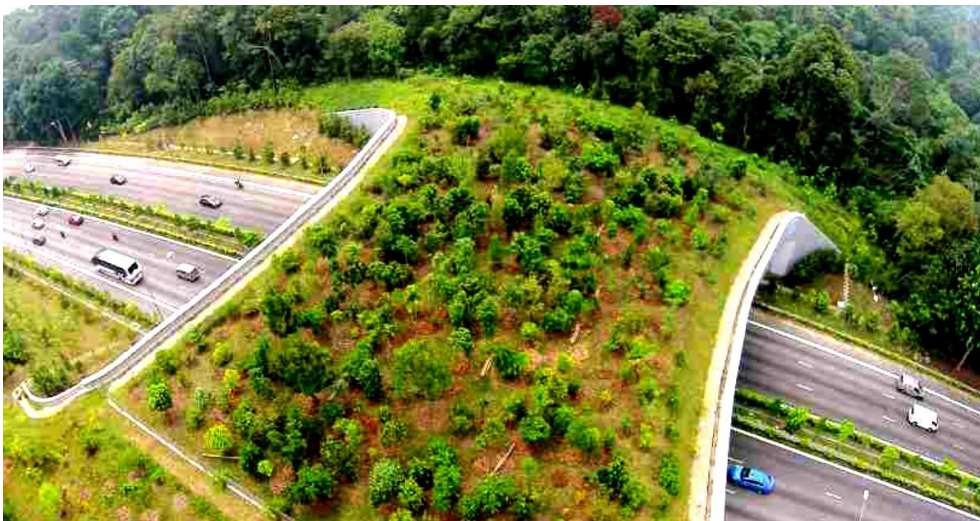
Figure 50 (c): Overpass representations (<https://arc-solutions.org/new-materials/>)
