**Sub: - Proposal for Tinaighat- Castlerock-Caranzol doubling of railway line by South Western Railways, Karnataka [Original Agenda Item No 58.5.1] Recommendations of the Standing Committee of National Board for Wild Life in 59th Meeting-Reg.**

**Figure 1:** Mitigation measures recommended on the existing and proposed railway tracks in the Tinaighat to Castlerock segment (Chainage 12/000 to 25/000)

## **CHAPTER 3: Mitigation Measures for the doubling of the Tinaighat-Castlerock-Caranzol SWR Railway Track**

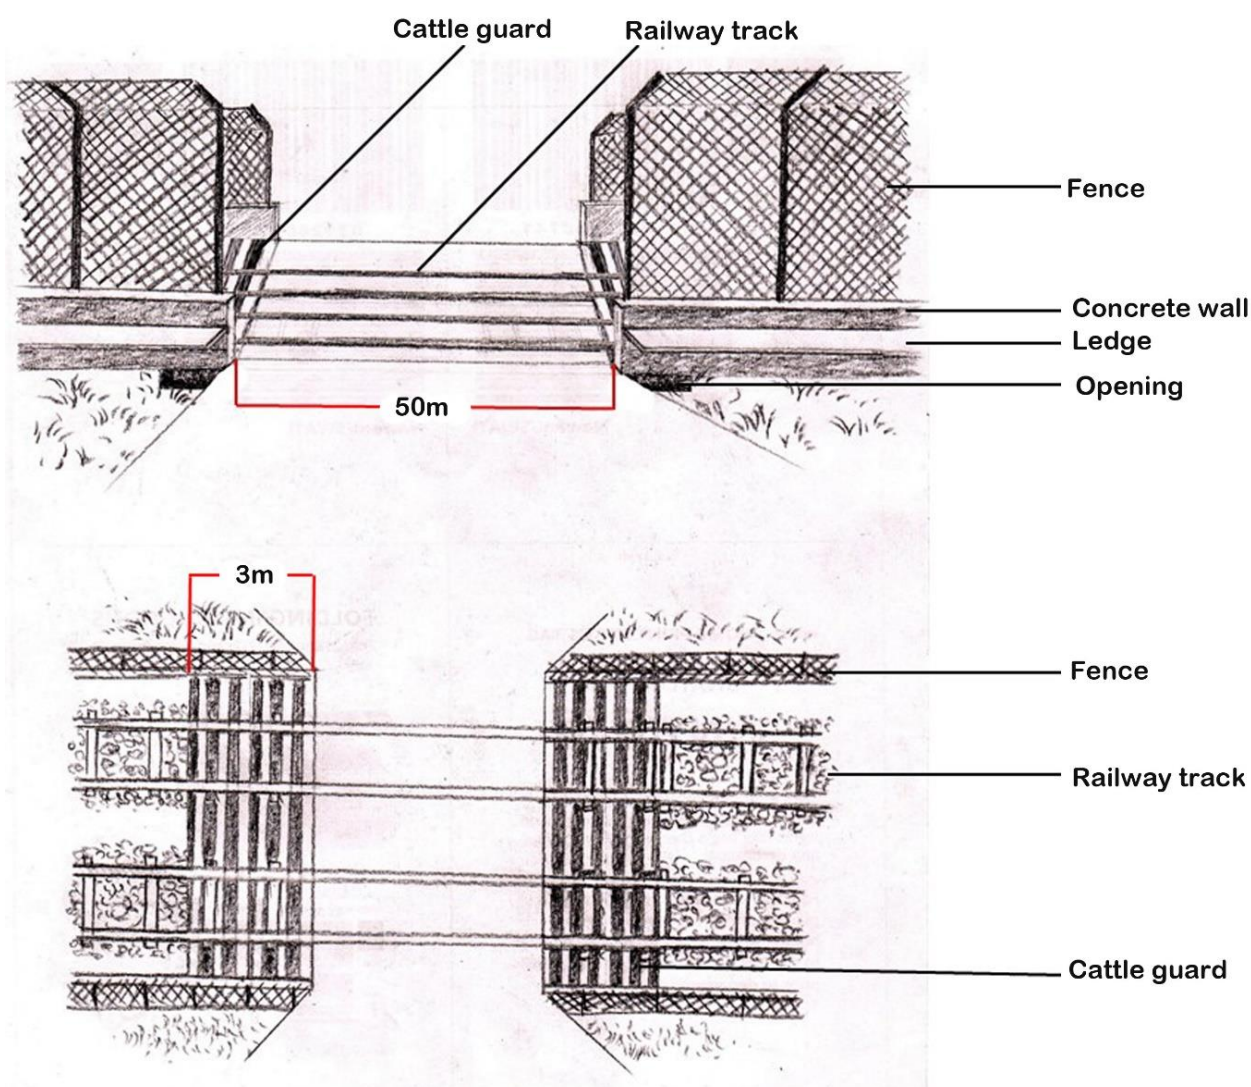
Figure 51: Layout of level crossings for animals.
